# Move In - w/Compliance

13707 Village Mill Dr  
Hagerstown MD 21767

**Survey date:** 2023-05-05

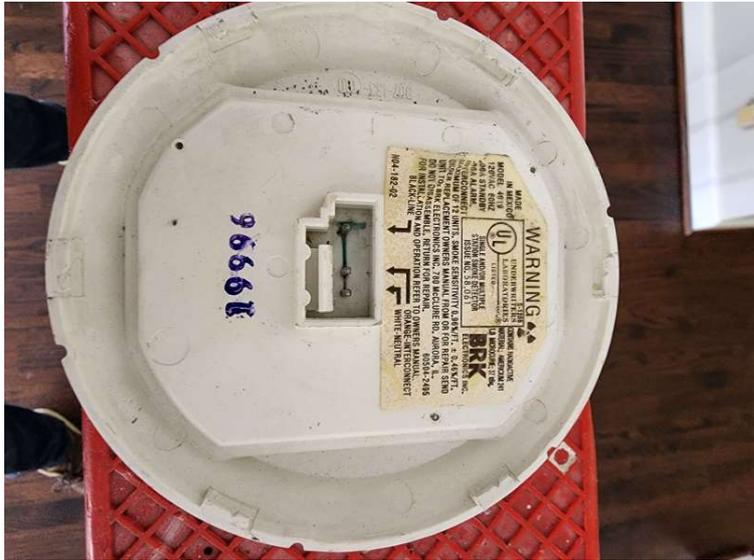
Common area hardwired combination smoke/co detector in non-compliant condition.

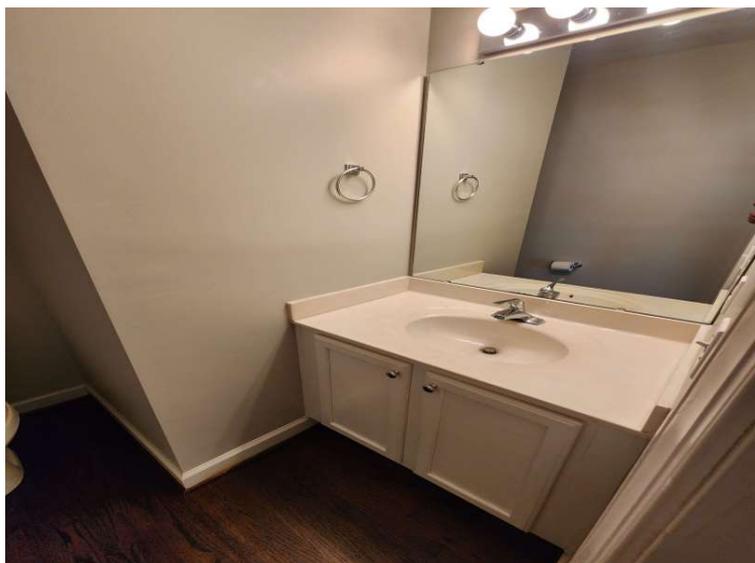
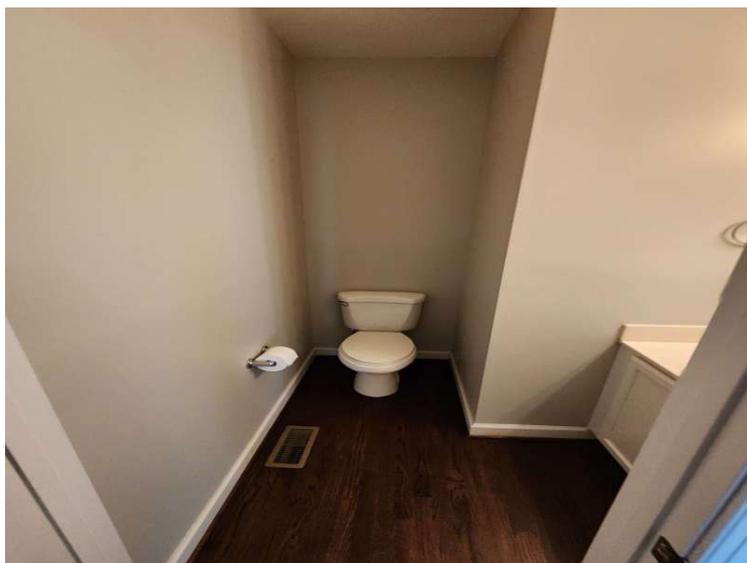
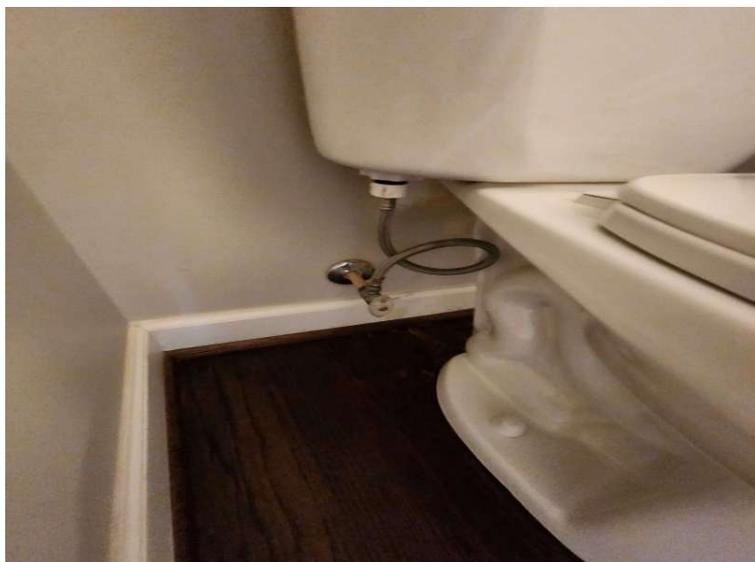
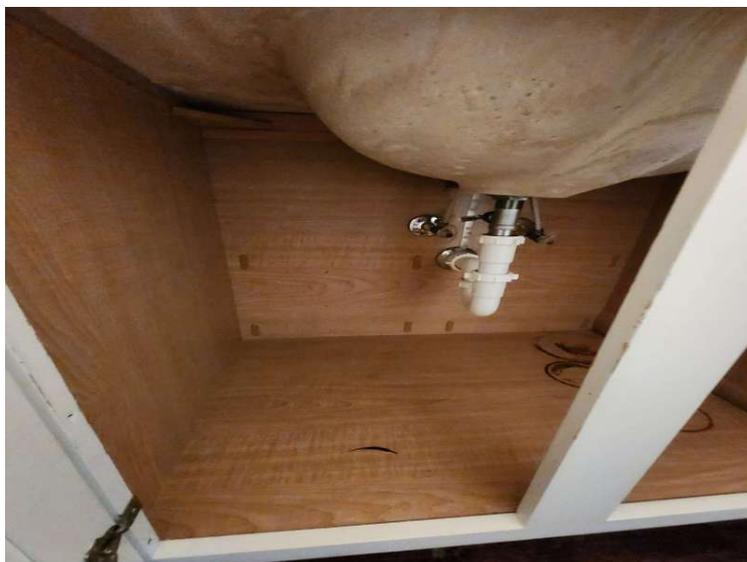
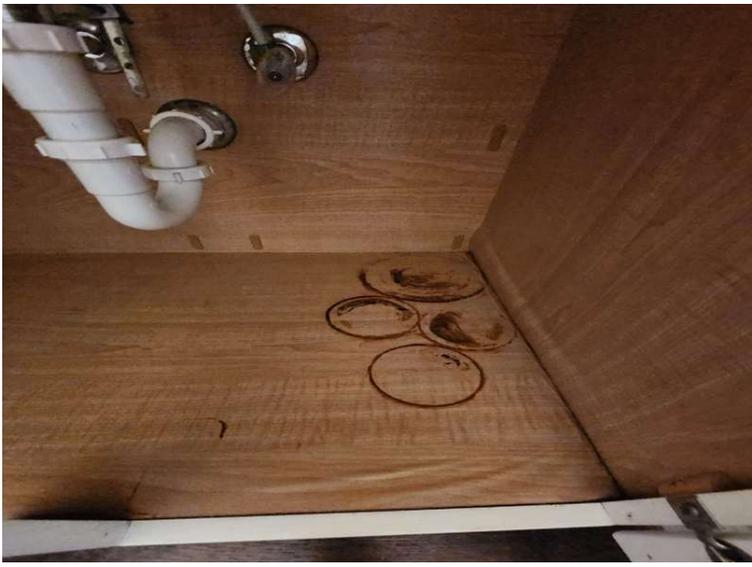
| Item: | Results: |
|---|---|
| Bathroom issues found? | Yes |
| Bathroom vent fan is? | Broken/disabled or inoperable |

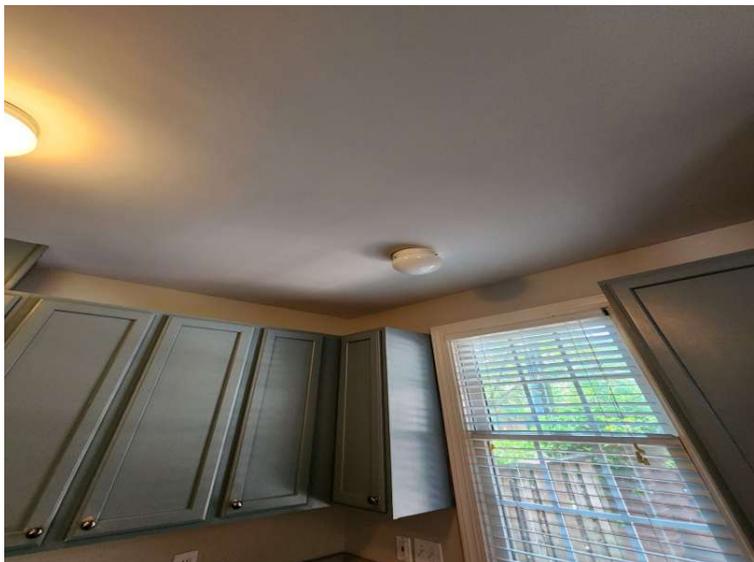
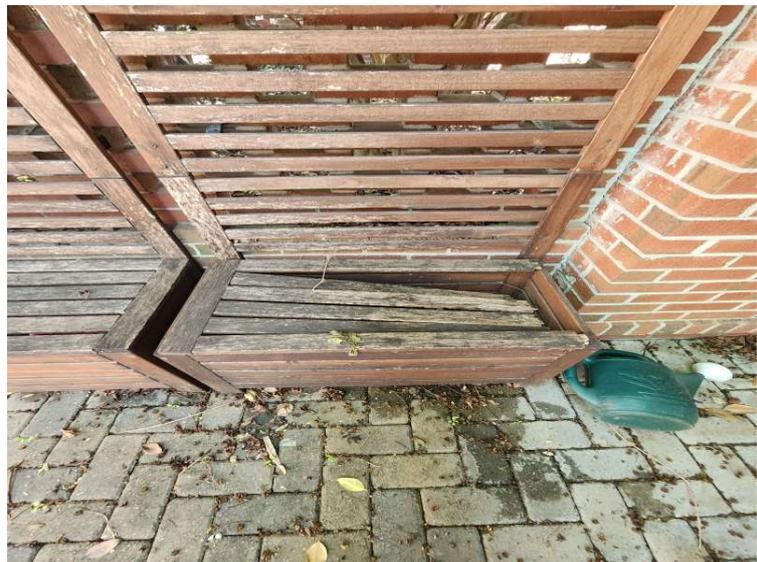
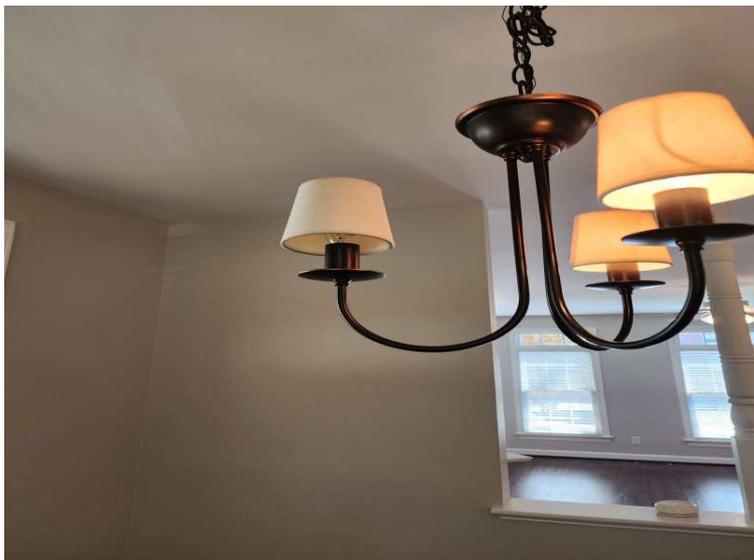
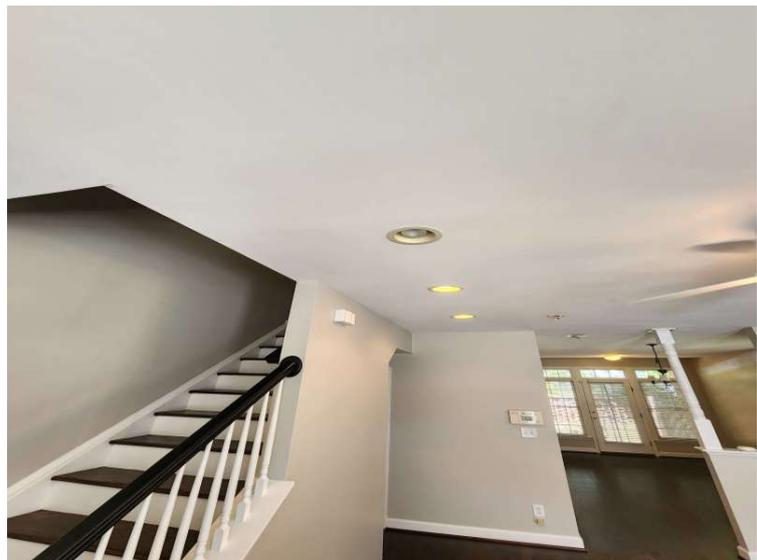
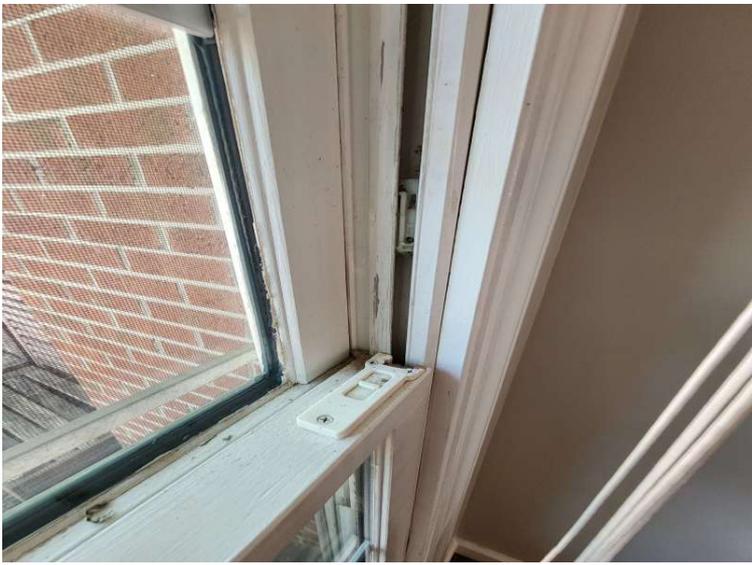
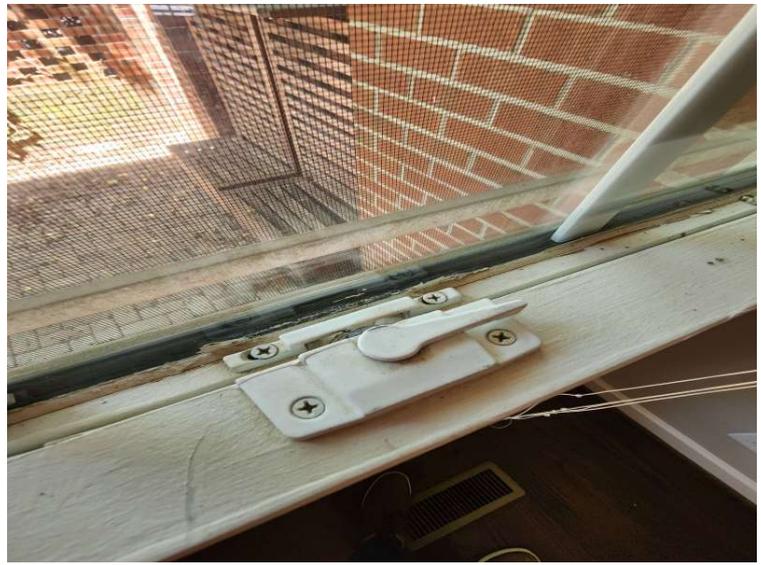
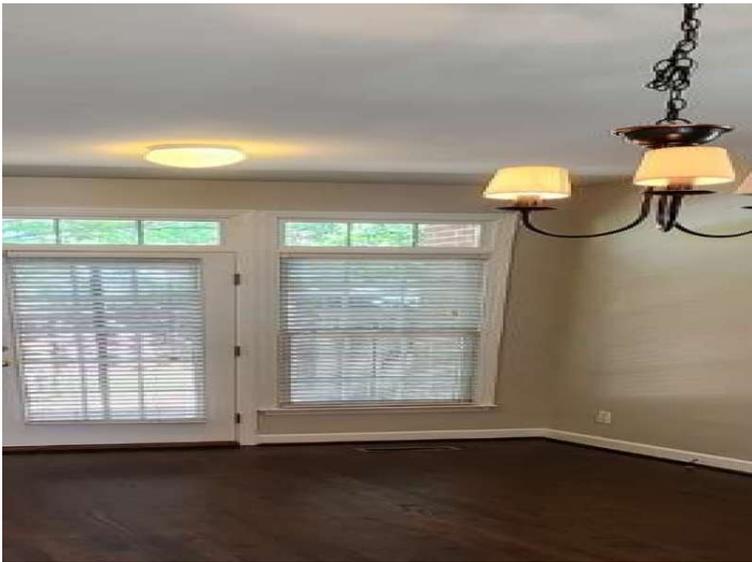
| Item: | Results: |
|--|---|
| Any maintenance issues reported by the tenant? | <p>Broken window spring on rear window to right of rear door. Window does not open One light bulb out in dining fixture One light out in kitchen closest sink One recessed light out in living room Broken/rotten seat in rear yard</p> |
