# Periodic Smoke Alarm & Property Survey

2250 Old Brick Rd  
Glen Allen VA 23060

**Survey date:** 2025-02-25

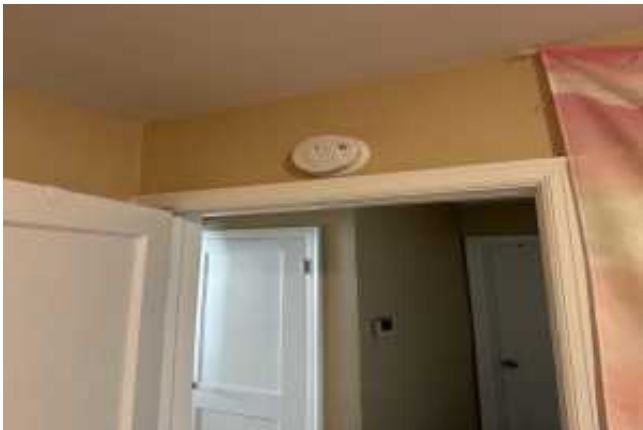
Bedroom battery smoke detector in good condition.

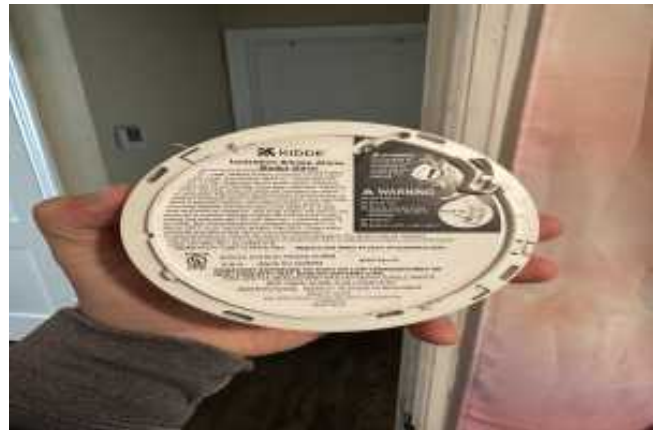
Bedroom battery smoke detector in good condition.

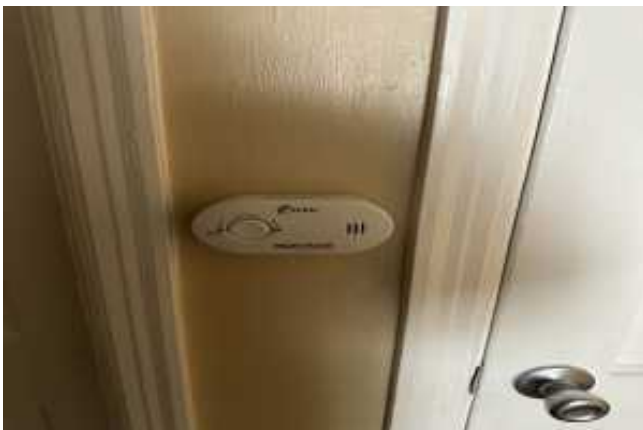
Common area battery co detector in good condition.

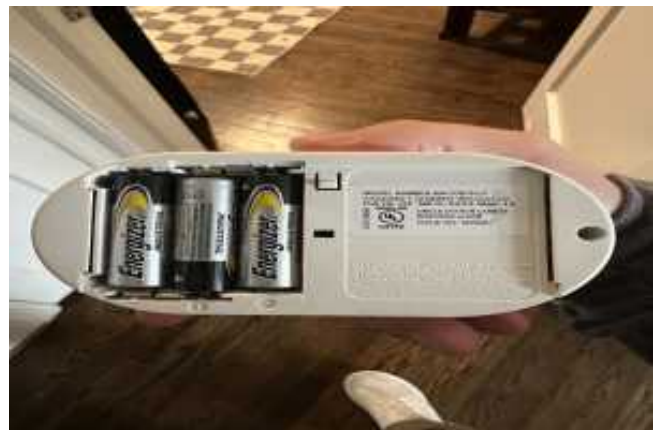
Common area battery co detector in good condition.

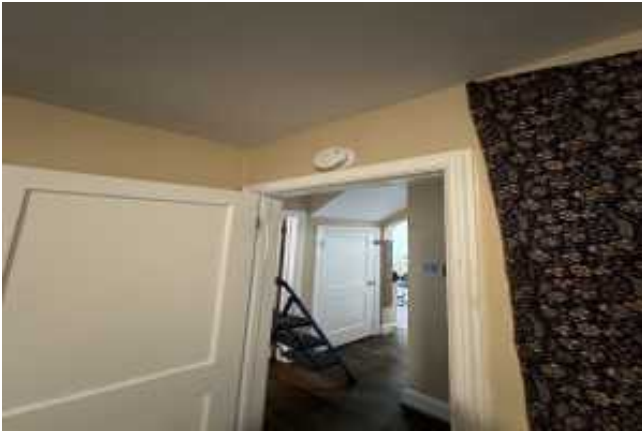
Bedroom battery smoke detector in good condition.

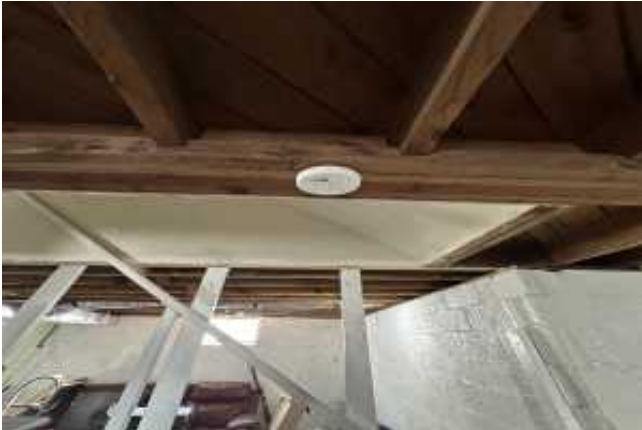
Common area battery co detector in good condition.

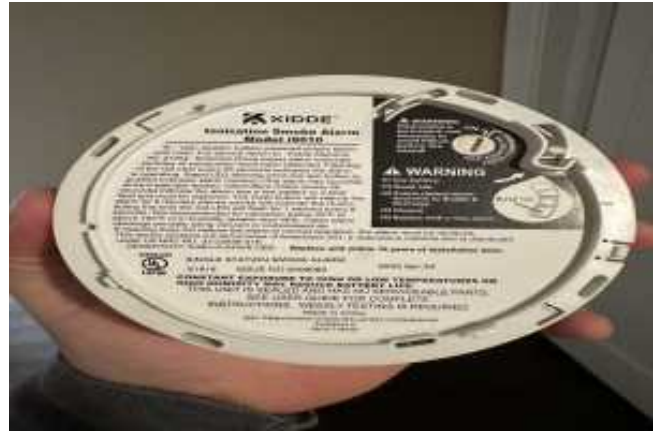
Bedroom battery smoke detector in good condition.

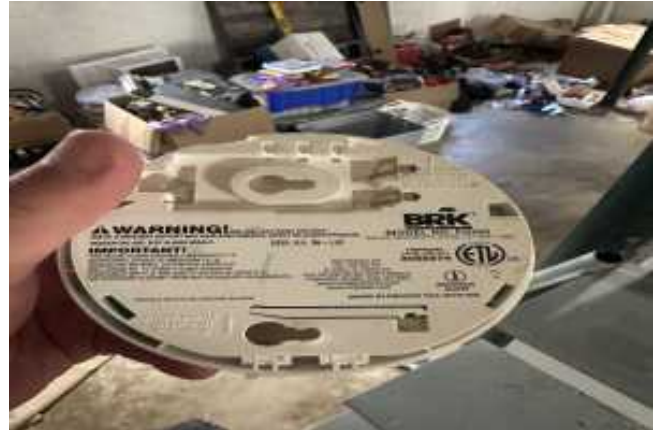
Common area battery co detector in good condition.

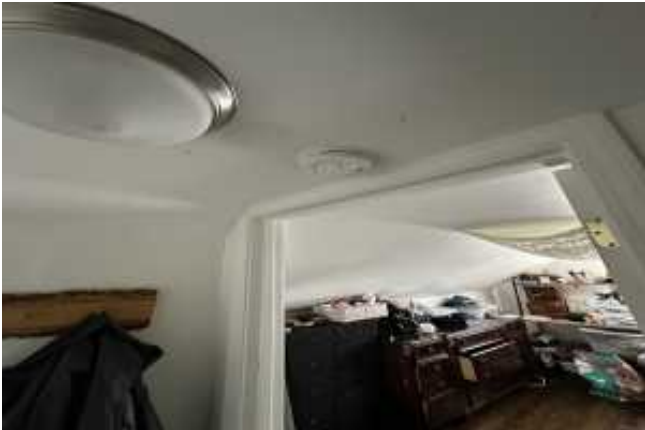
Common area battery smoke detector in good condition.

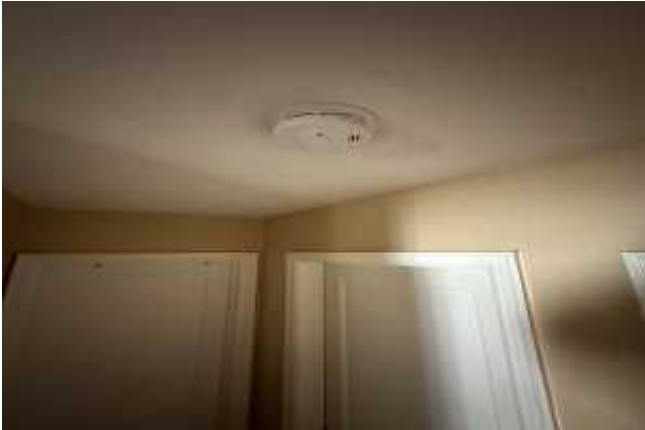
Common area battery smoke detector in good condition.

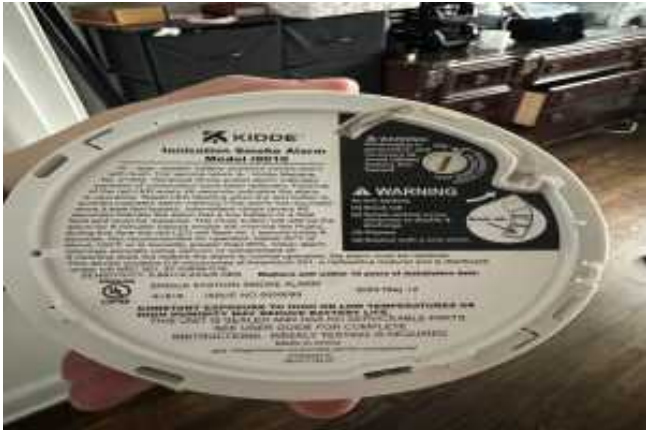
Common area battery smoke detector in good condition.

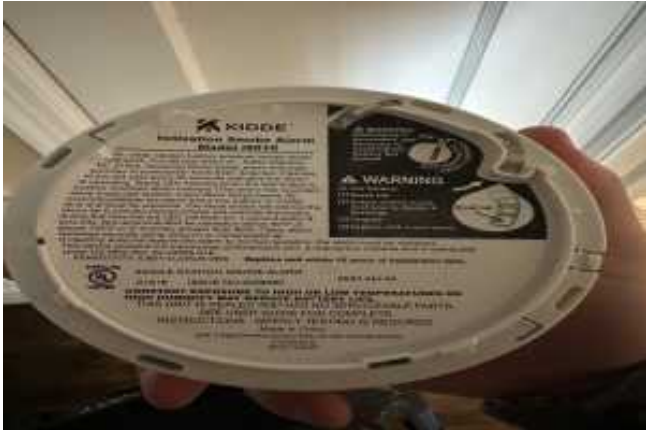
Common area battery smoke detector in good condition.

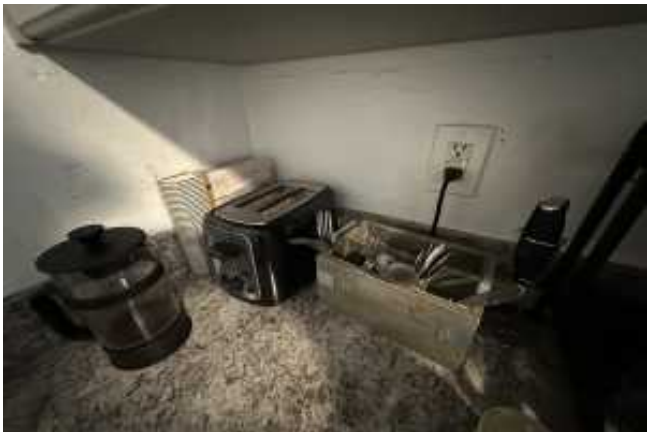
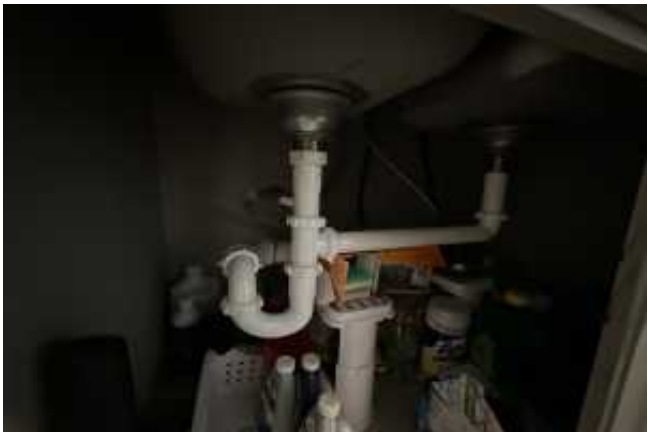
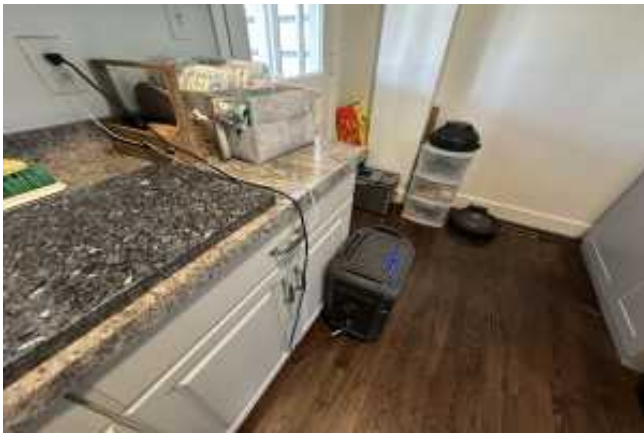
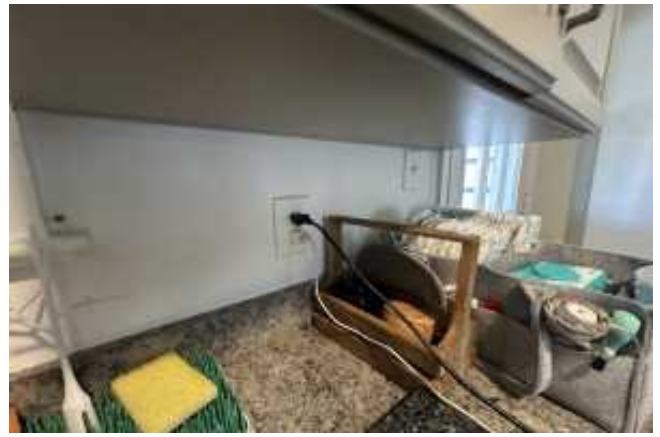
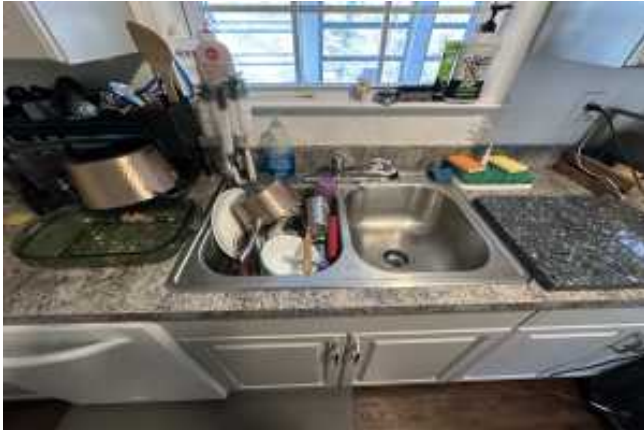
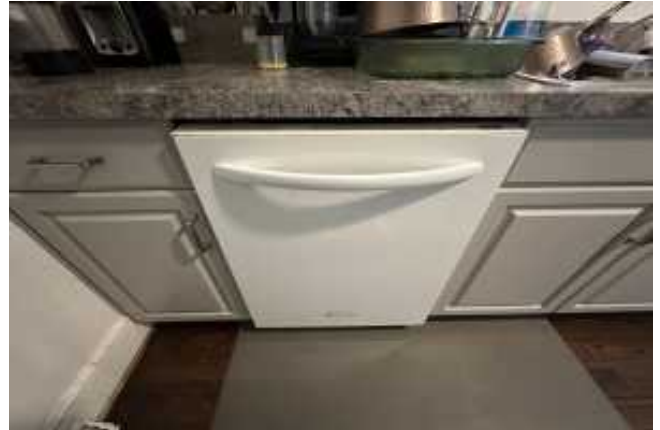
Item:	Results:
Appliances are clean and free of excess grease and in good working condition?	No
Is there grease buildup or damage?	Grease buildup
Range hood or over the range microwave appears/reported to be in good working condition and free of excess grease?	No
Select all that apply?	Grease buildup
Small appliances are unplugged when not in use?	No
Things that can burn are not stored on the cooktop or in the range?	No
Floor covering condition including kitchen, dining area or eat in kitchen?	Good - Moderate Wear
Walls and Ceiling condition?	Good - Moderate Wear
Kitchen Cabinets are in good condition with no obvious damage or missing hardware?	Yes
Any signs of water damage in the kitchen?	No
Additional notes or findings:	Advised tenant that leaving things such as dish towels, and medicines on the burners of the range poses a hazard if burners are accidentally left on. Also advised the tenant to maintain a clean range, and range hood filter to prevent any issues (safety, pest, etc.)

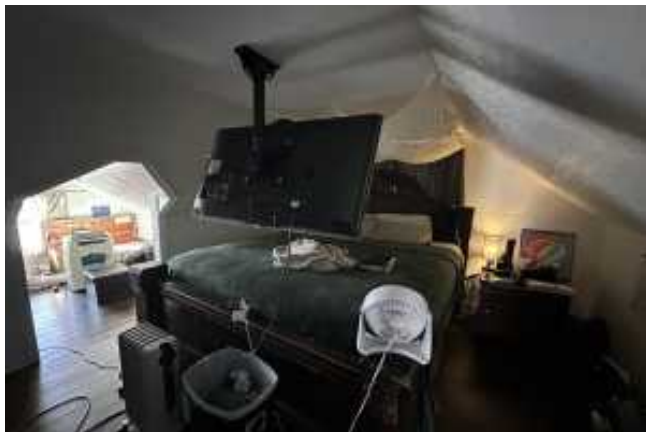
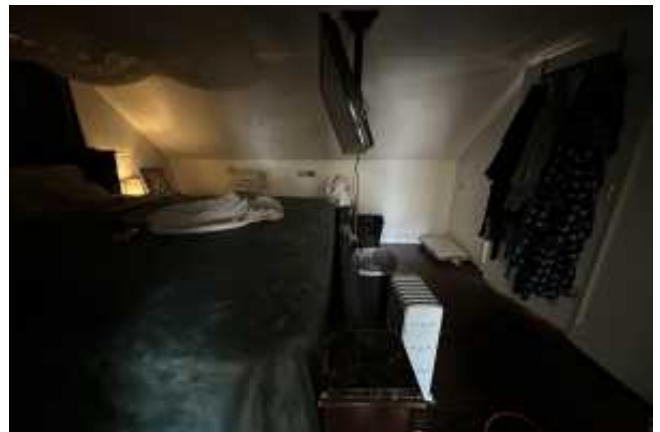
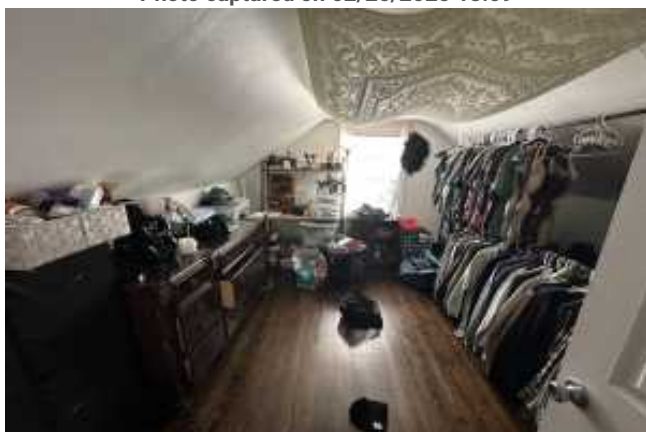
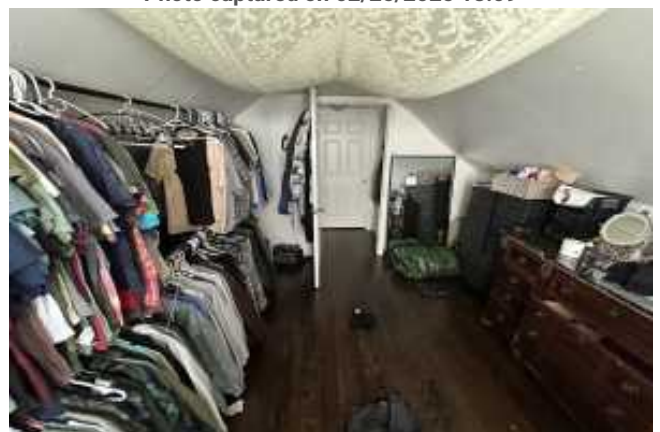
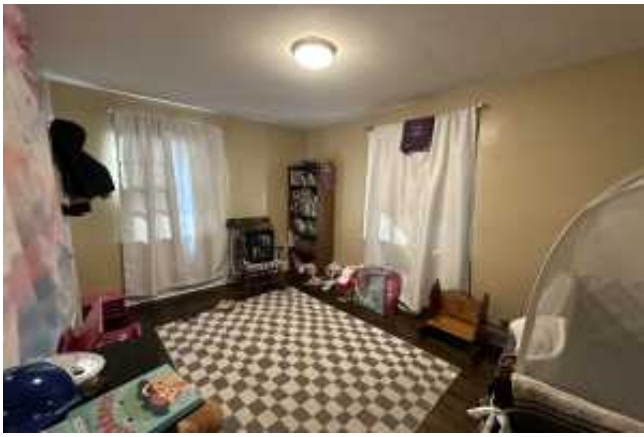
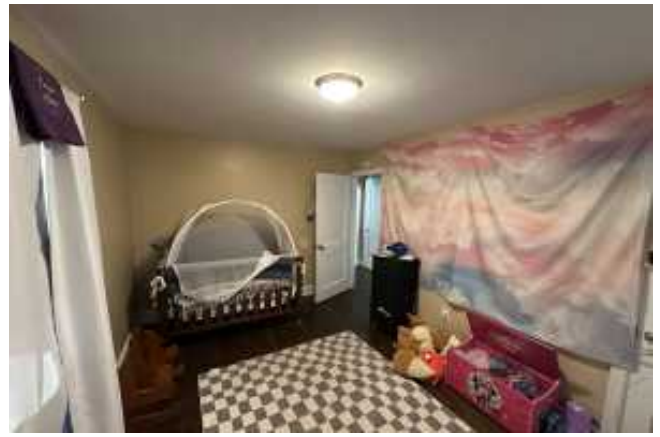
Item:	Results:
Total bedrooms	4
Bedroom has two operational and clear means of egress to separate locations inside or outside of the residence?	No - Lack of proper egress
Floor covering?	Wood, laminate or linoleum
Condition of floor covering?	Good - Moderate Wear
Walls and Ceiling condition?	Good - Moderate Wear
Additional notes or findings:	In the bedroom upstairs and to the left, the tenant has a bed blocking egress to one window, but has clear egress to another accessible window.

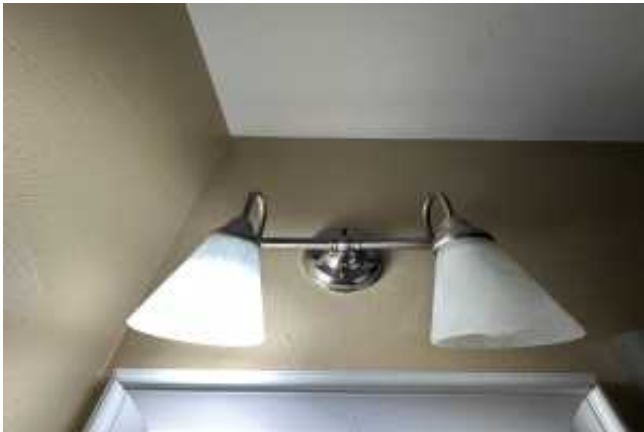
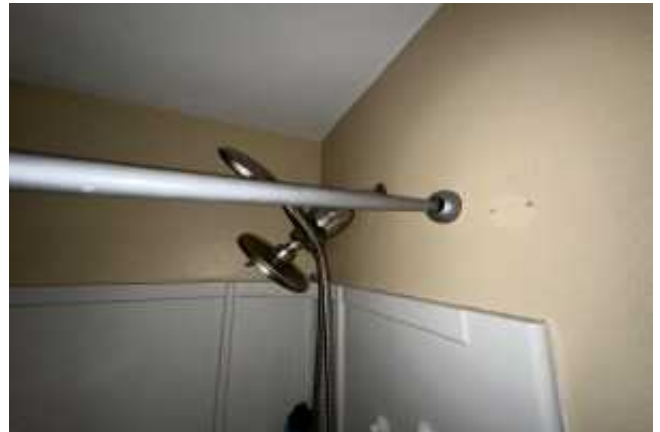
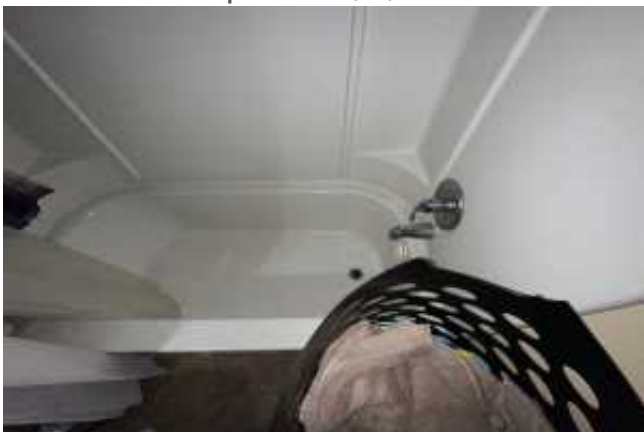
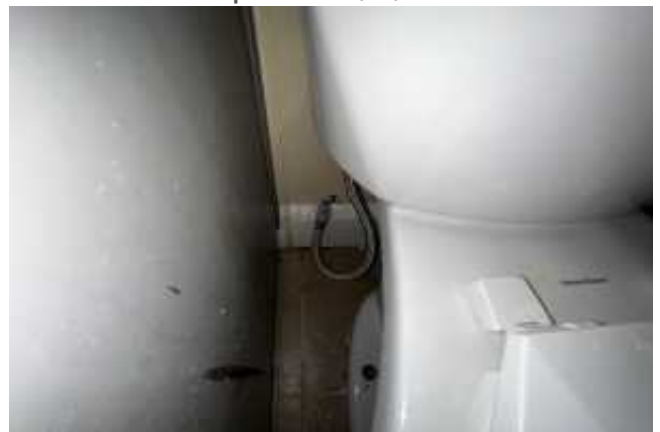
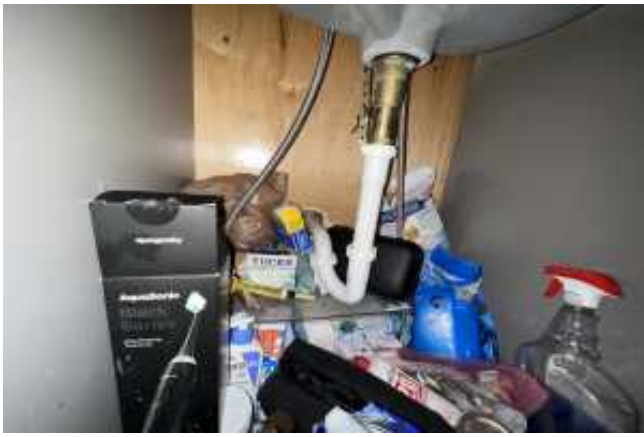
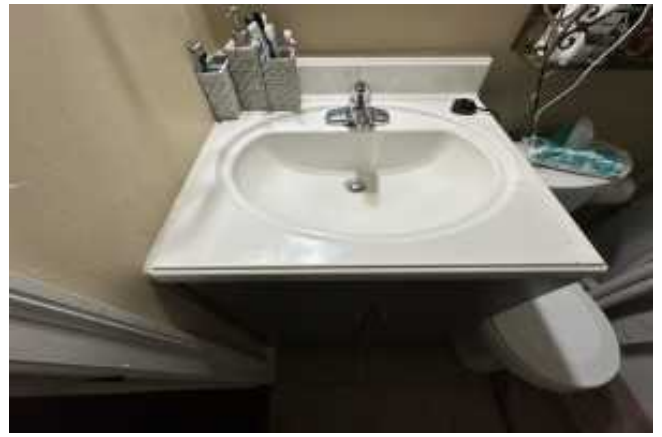
Item:	Results:
Total full bathrooms	1
Water Sources?	Stainless Braided Cables
Bathroom vent fan is?	Dirty
Shower or tub condition?	Good condition
Condition of floor covering?	Good - Moderate wear and tear
Condition of walls and ceiling?	Good
Vanity in good condition?	Yes
Light fixtures are in good working condition?	No
Condition of light fixtures	Light bulbs out or missing
Additional notes or findings:	--

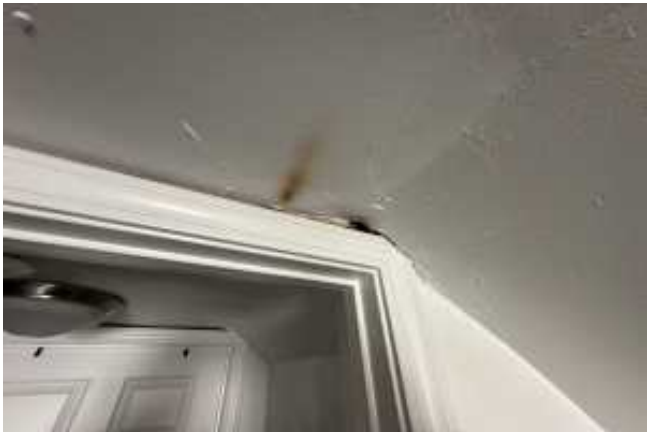
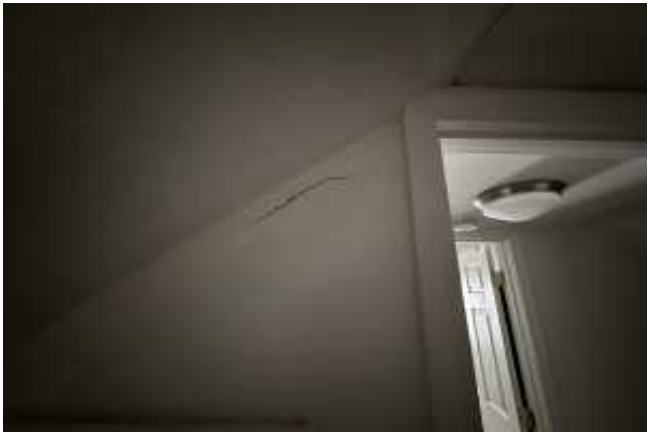
Item:	Results:
Any maintenance issues?	Yes
Recommended Maintenance	<p>Both bedrooms upstairs had some wall damage that should be addressed. In one bedroom directly above the doorframe, it appears that there was past damage, even possible burning?</p> <p>The other room has some cracking in the wall, potentially foundation settling.</p>
