# Move In - w/Compliance

13707 Village Mill Dr  
Hagerstown MD 21767

**Survey date:** 2023-05-05

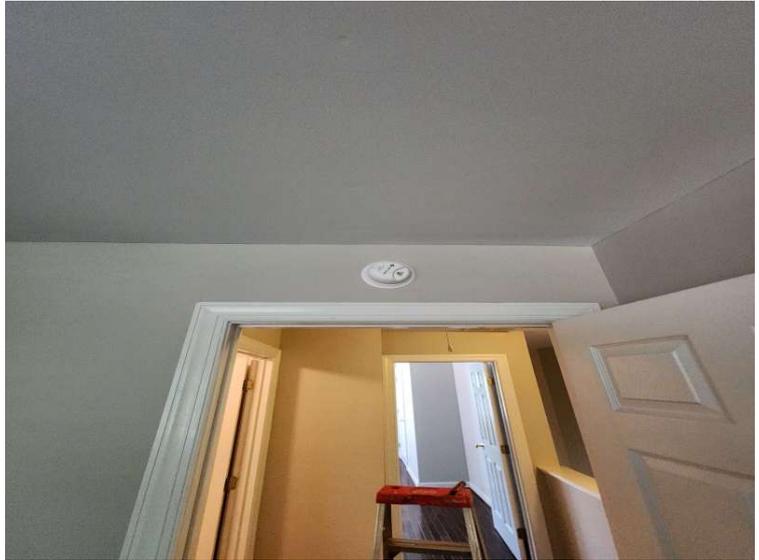
Bedroom smoke detector

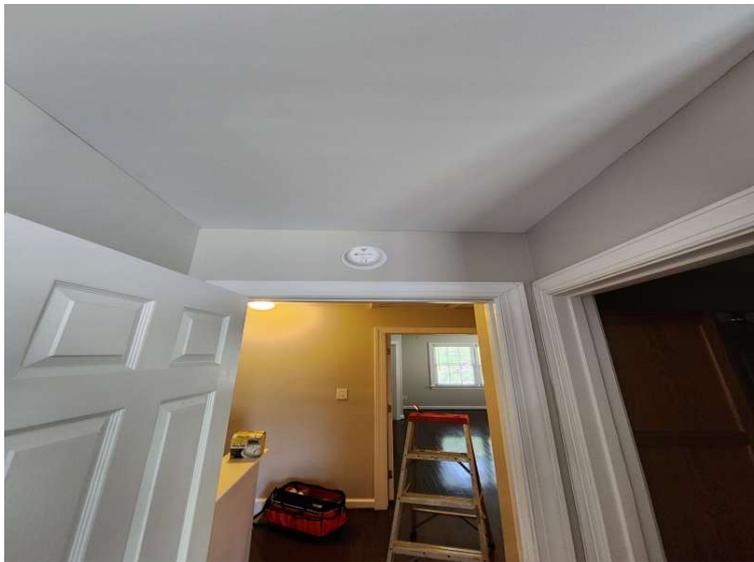
Bedroom smoke detector

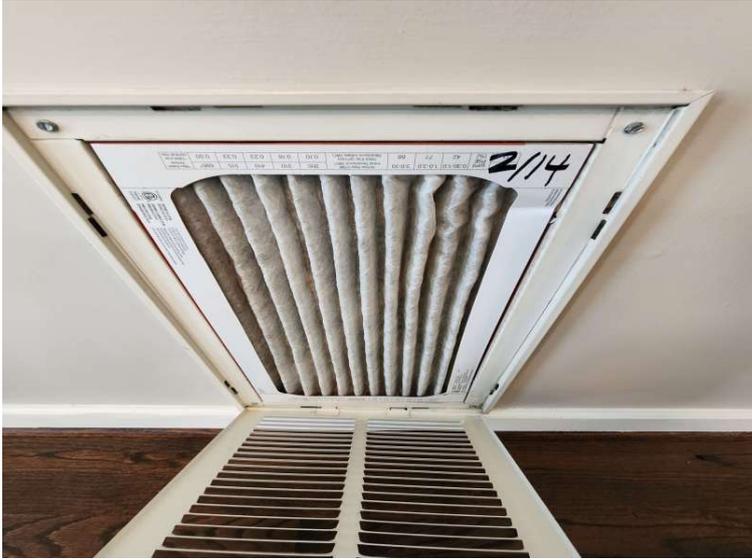
Clean 10x20x1 in common area

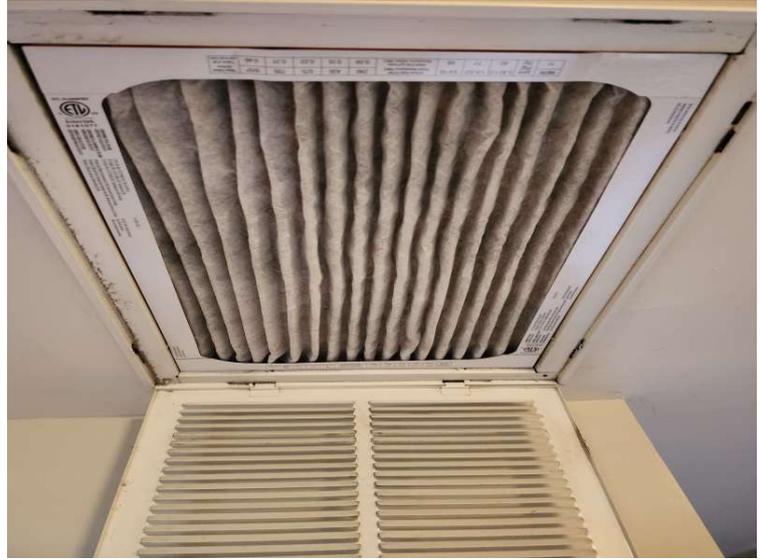
Clean 14x20x1 in common area

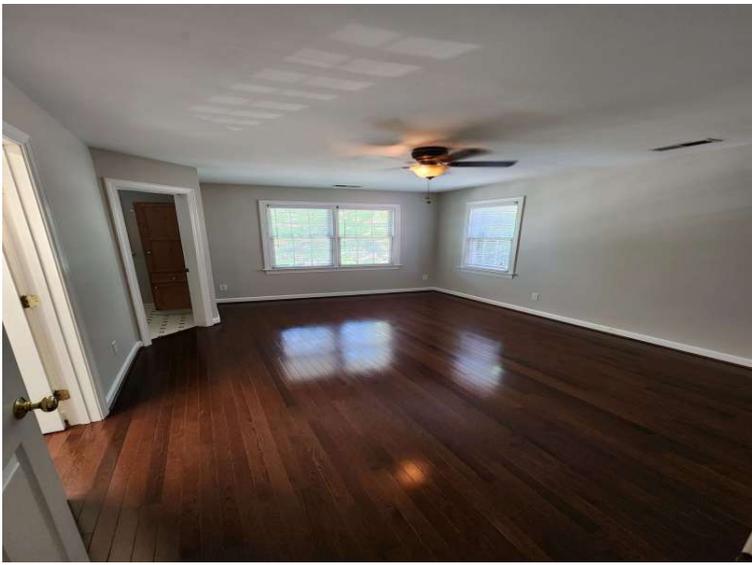
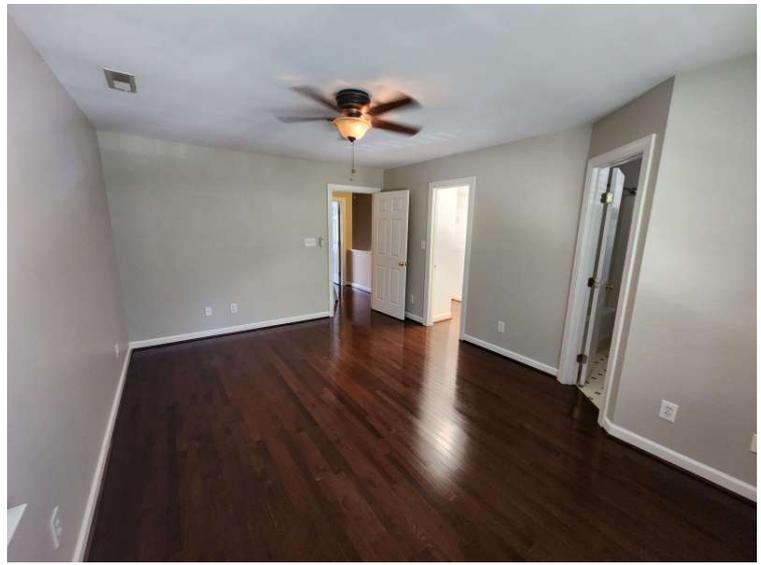
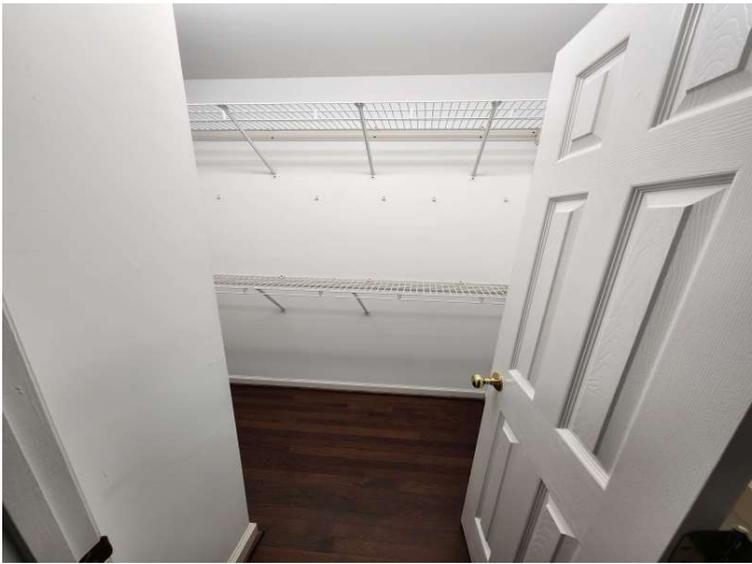
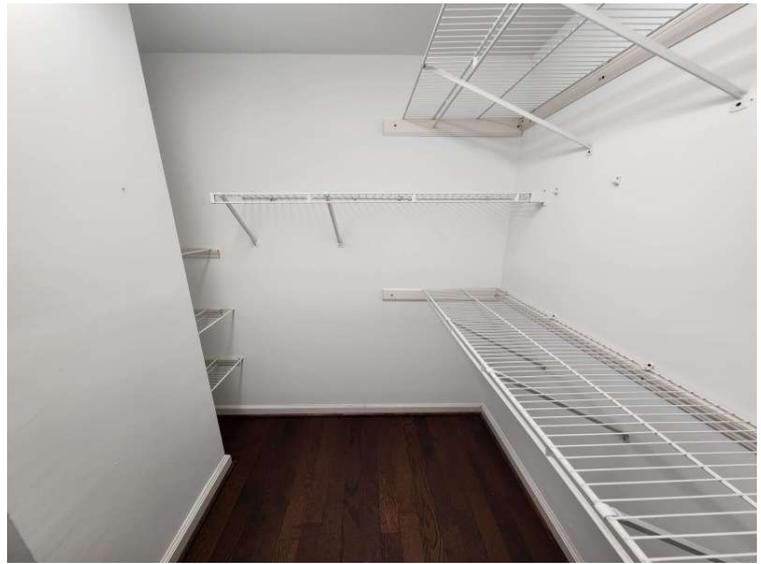
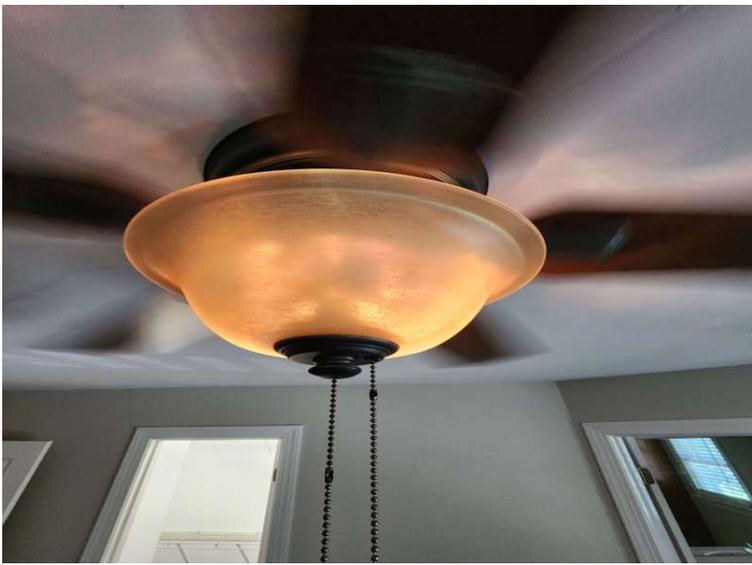
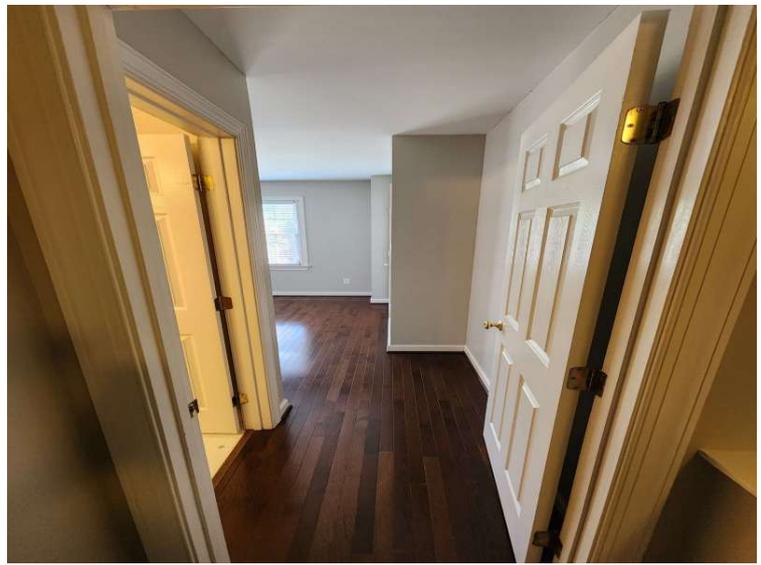
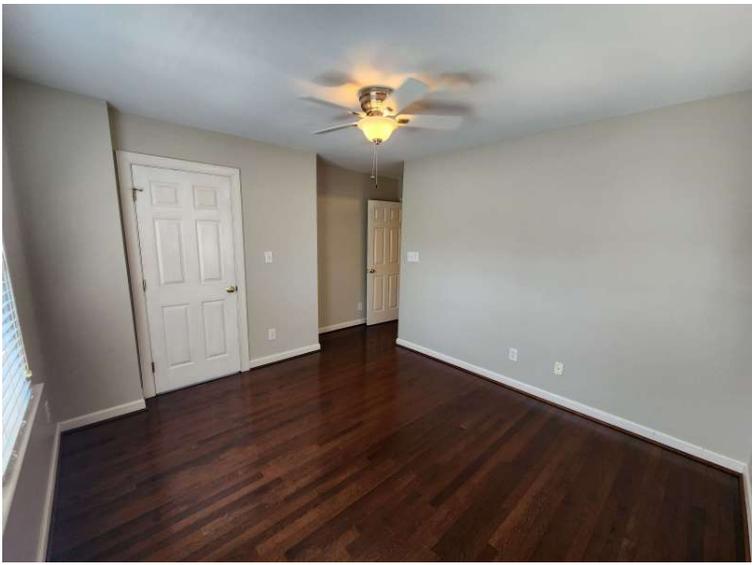
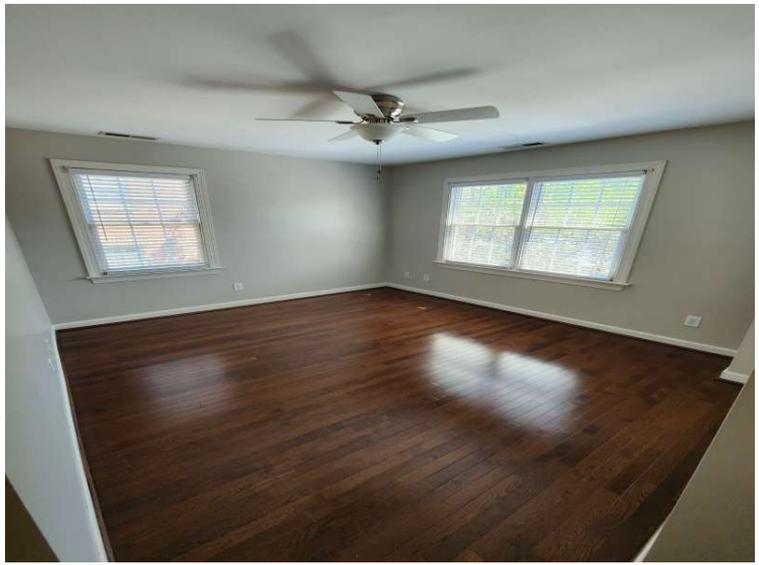
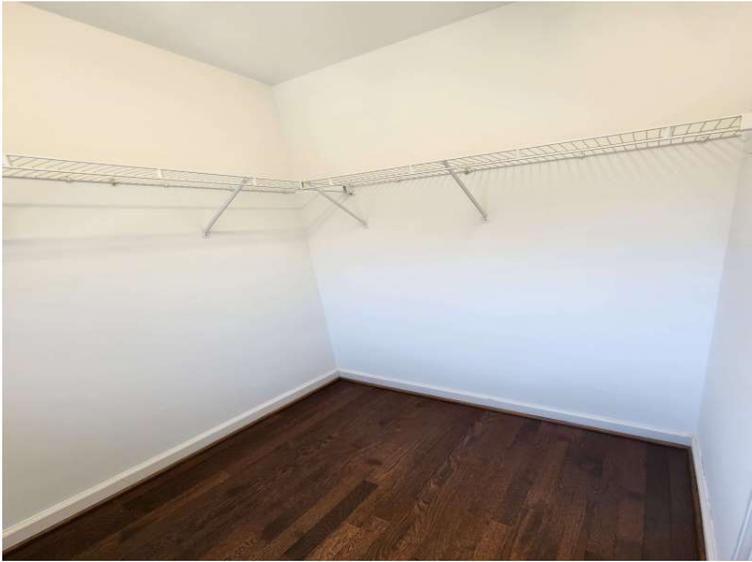
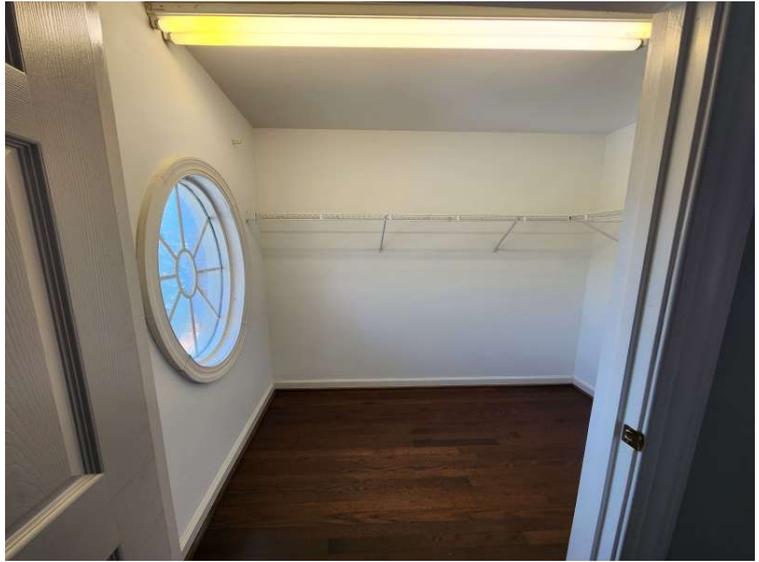
| Item: | Results: |
|---|---|
| Condition of closets? | Great |
| Condition of floor covering? | Great |
| Walls and Ceiling condition? | Great |

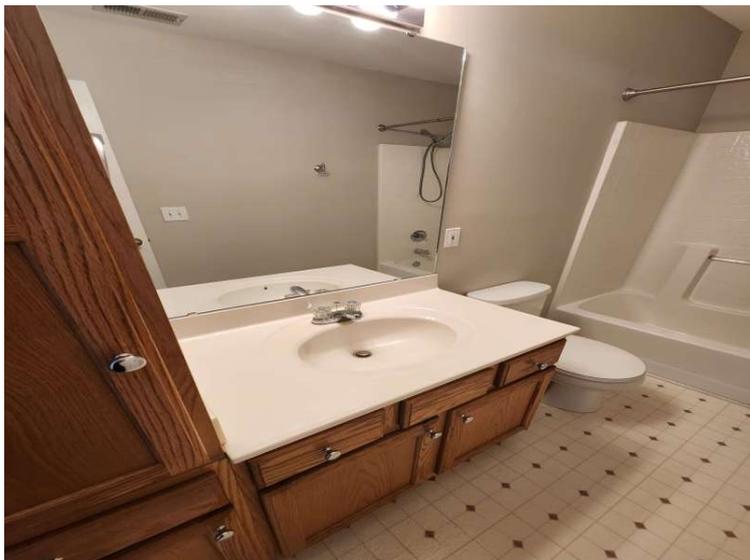
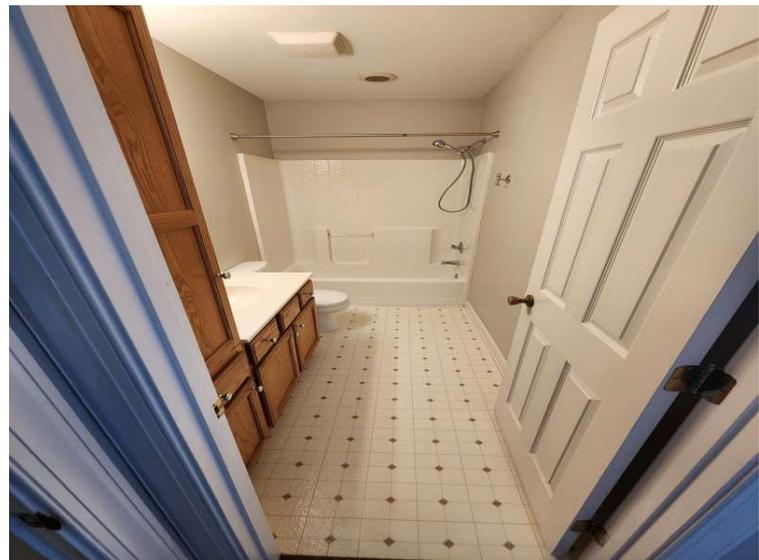
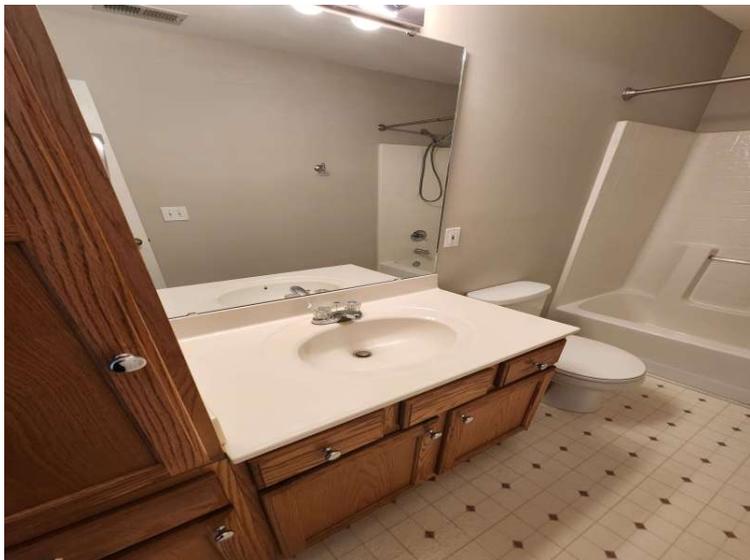
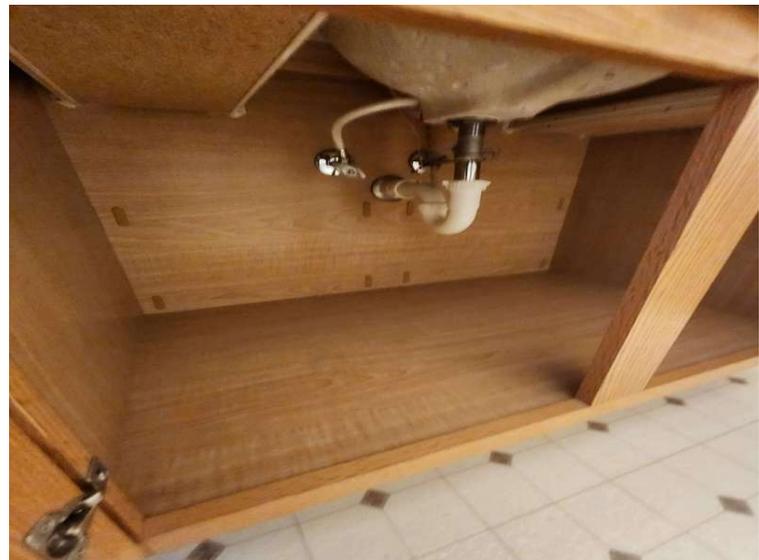
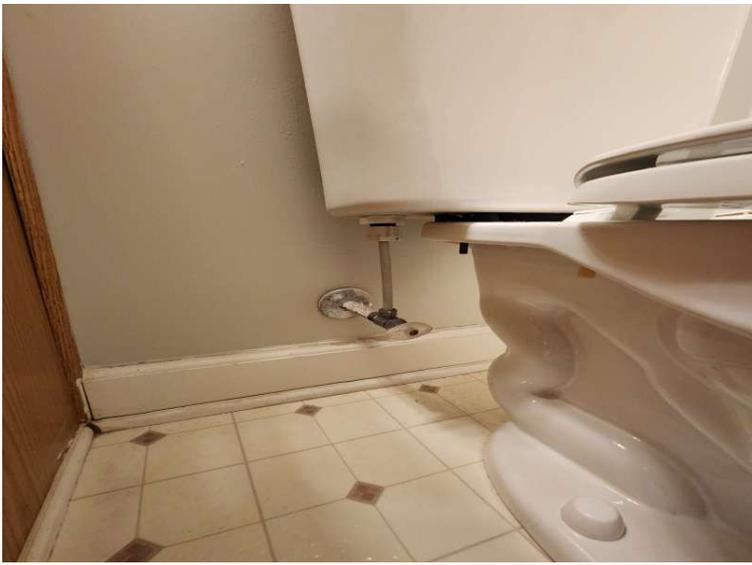
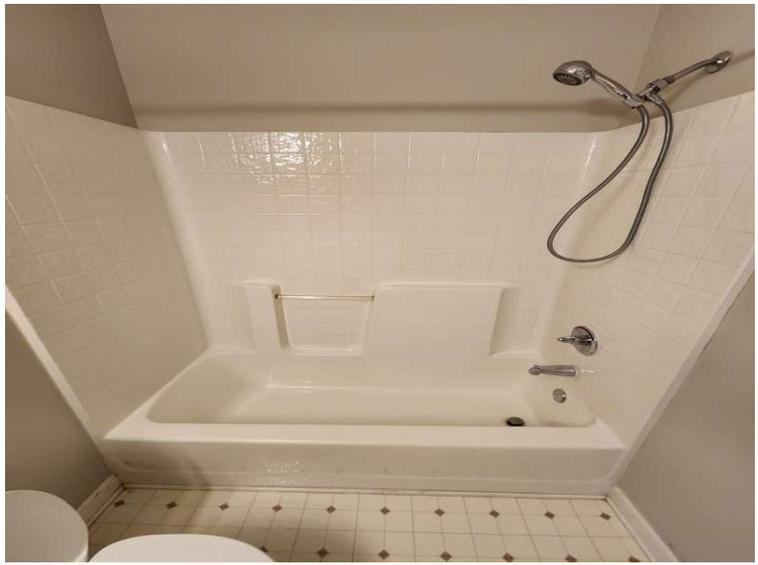
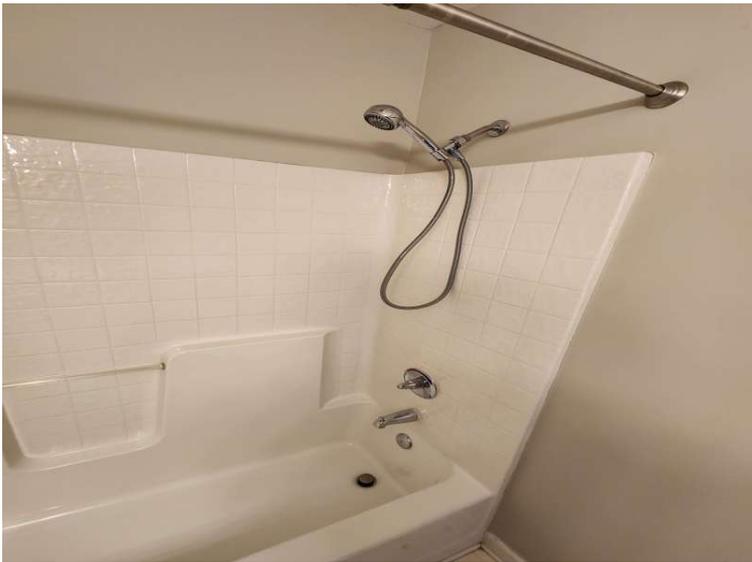
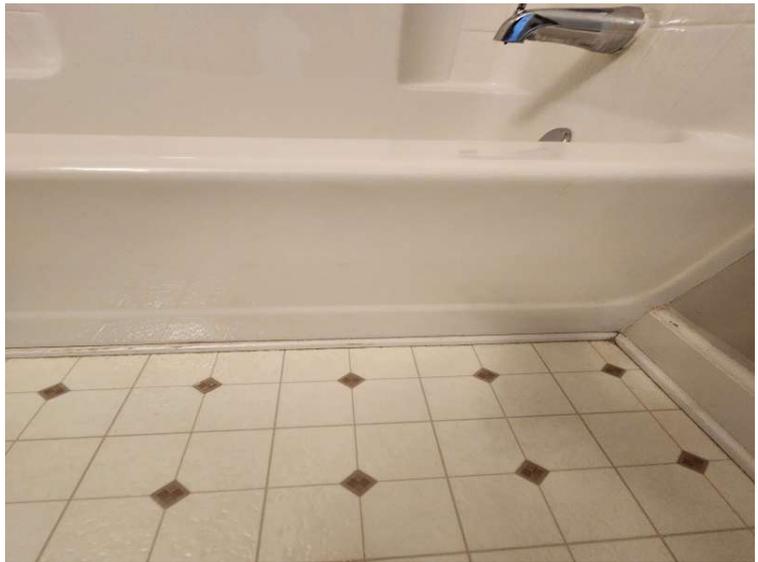
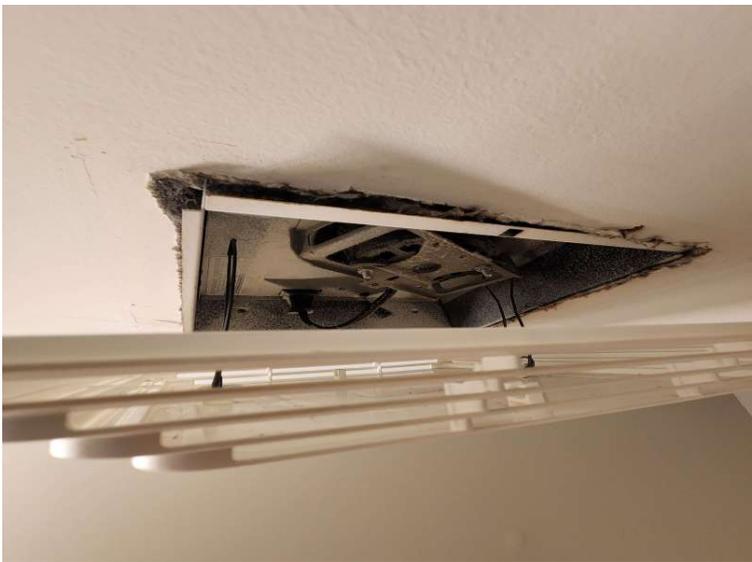
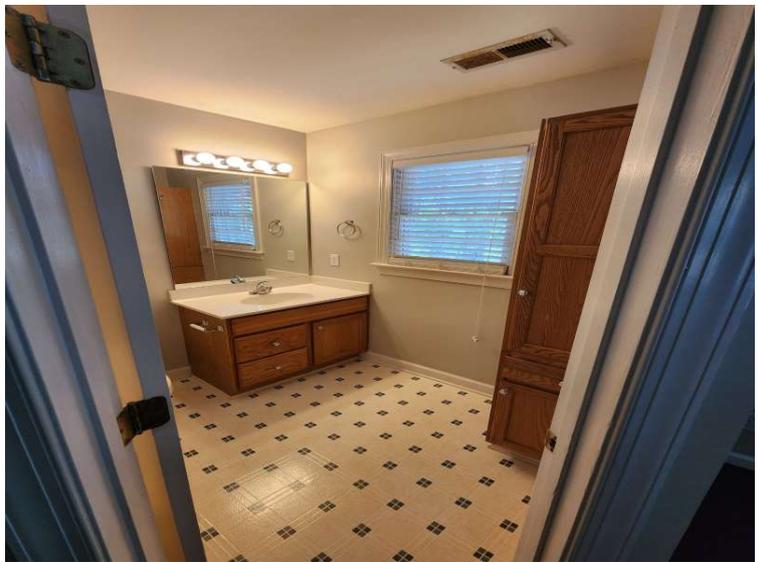
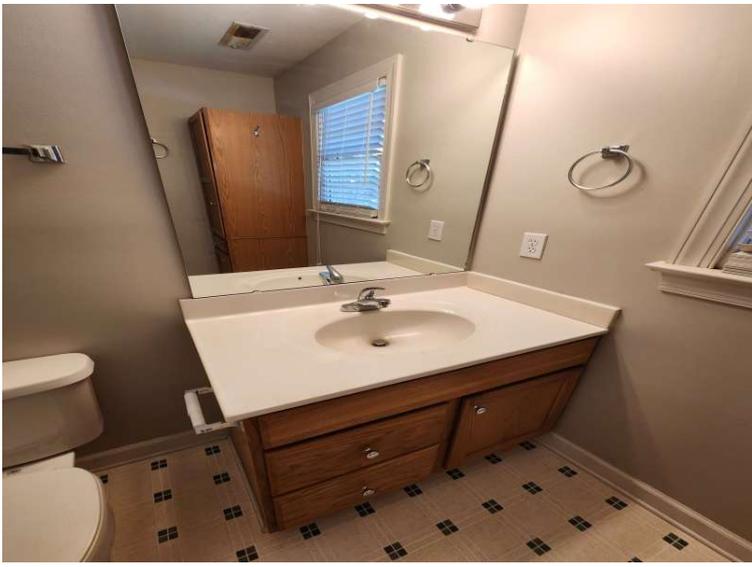
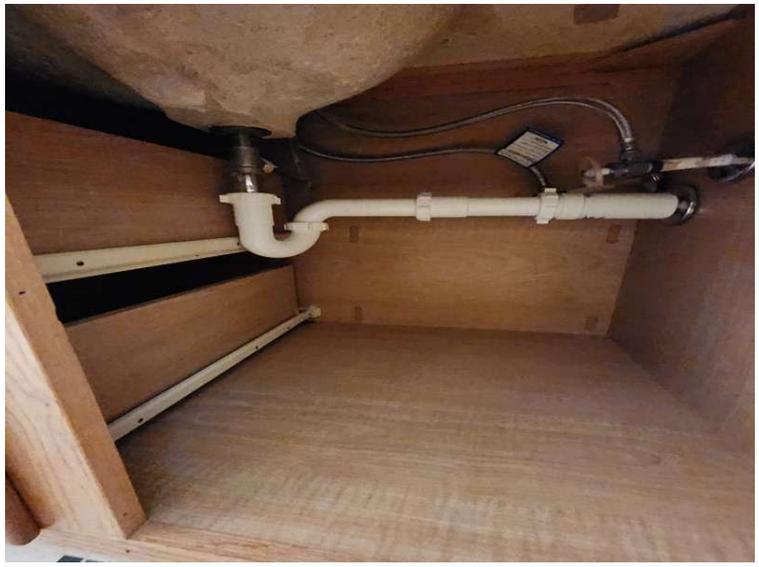
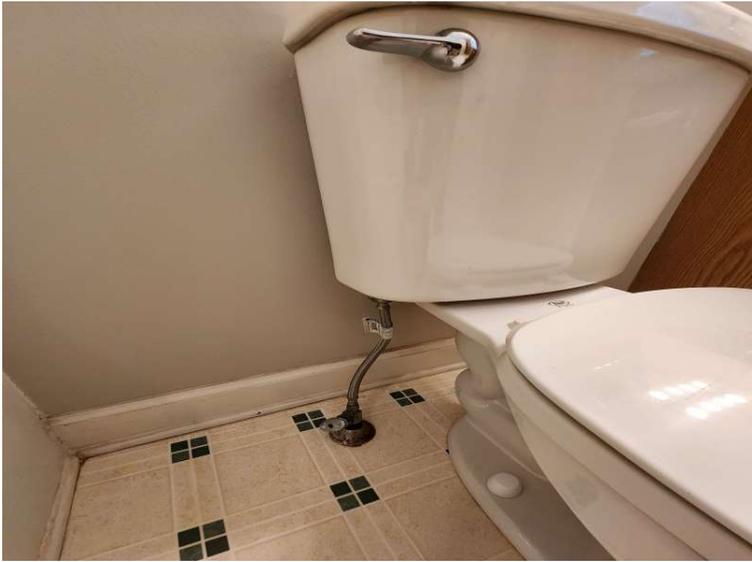
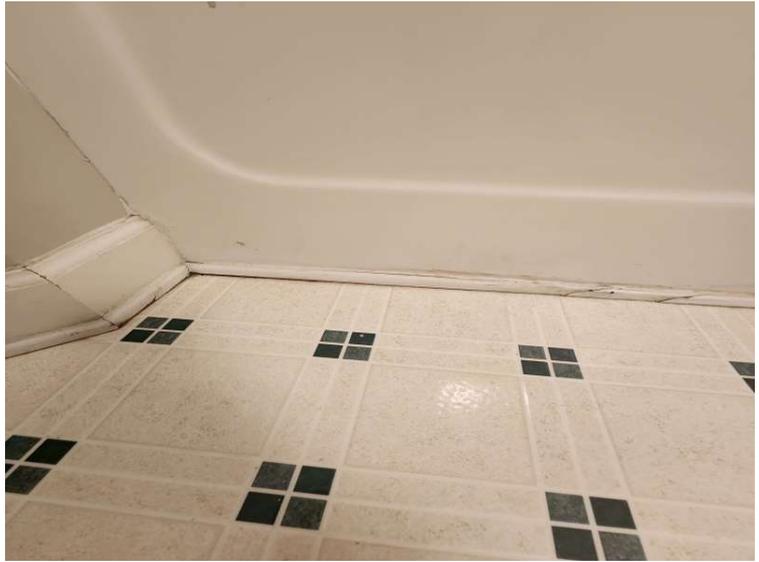
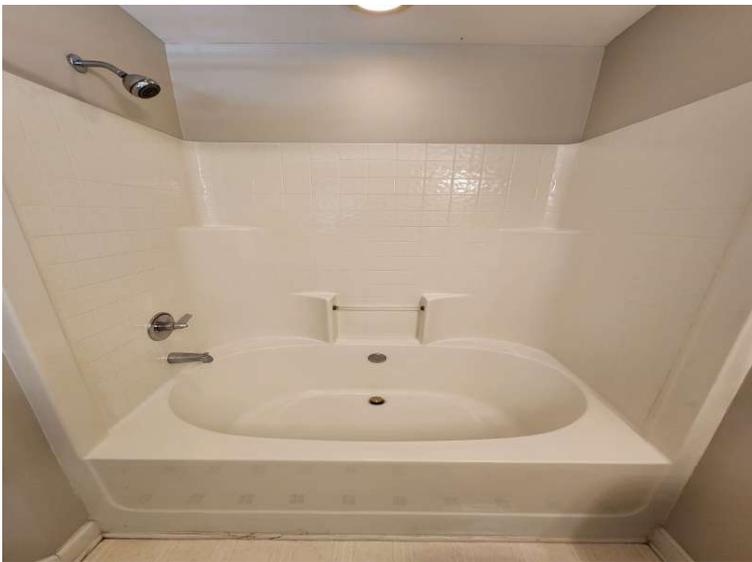
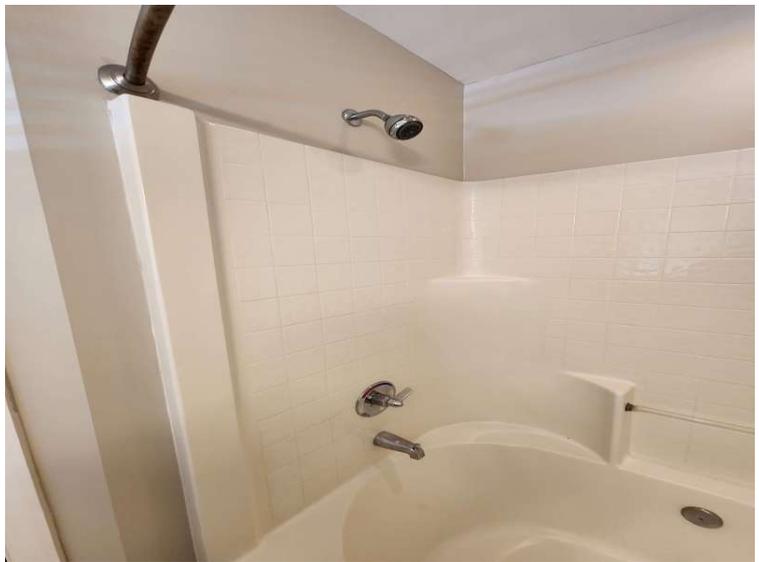
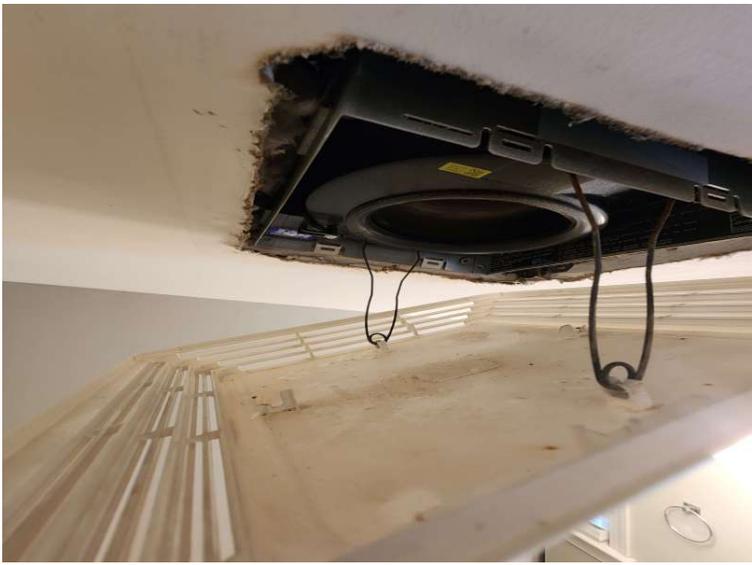
# Full bathrooms

| Item: | Results: |
|---|---|
| Bathroom issues found? | No |
| Bathroom vent fan is? | Clean and operational |
| Shower or tub condition? | Good condition |

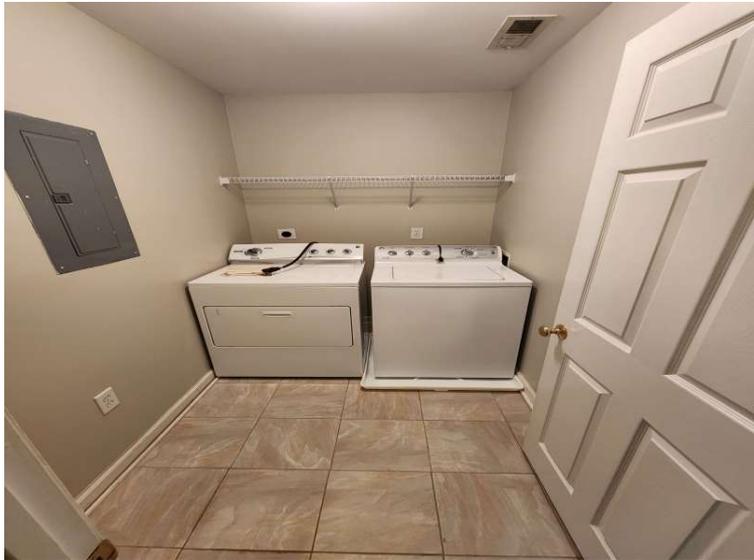
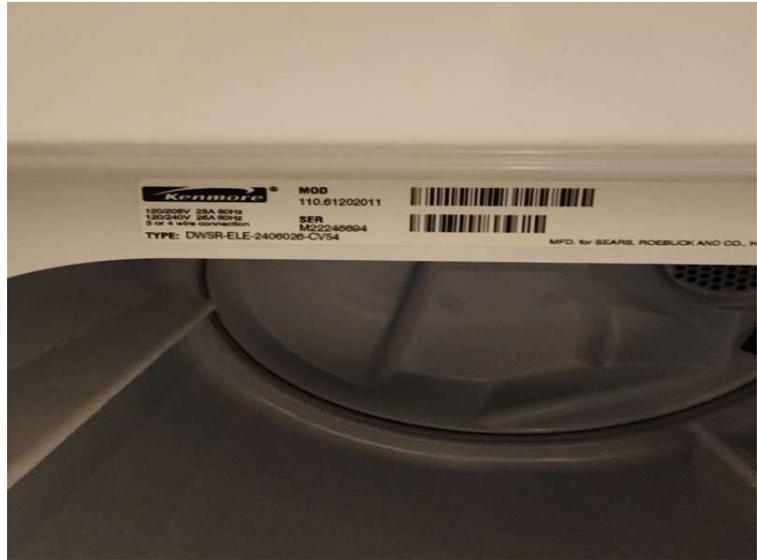
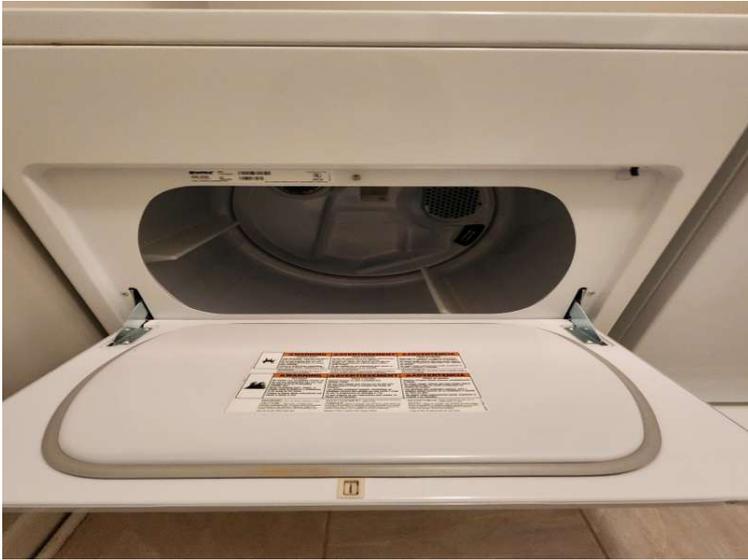
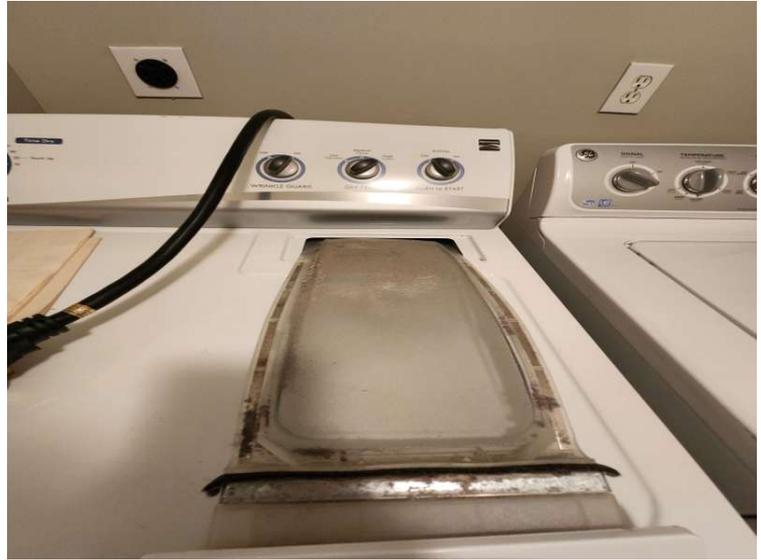
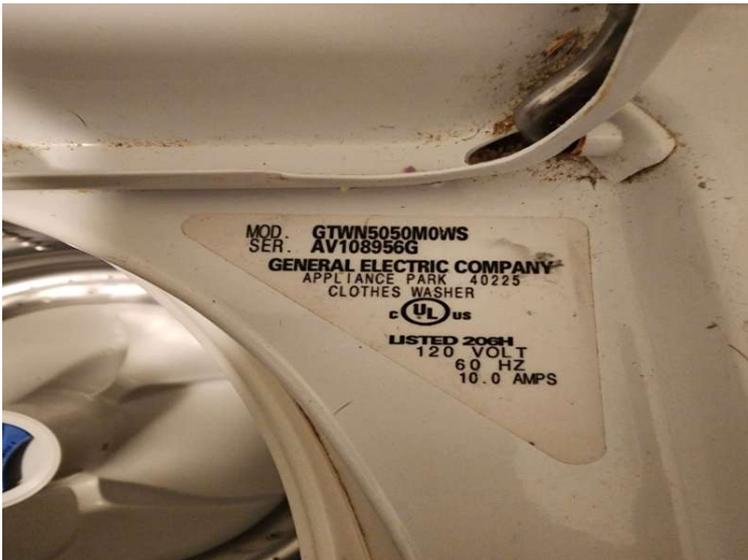
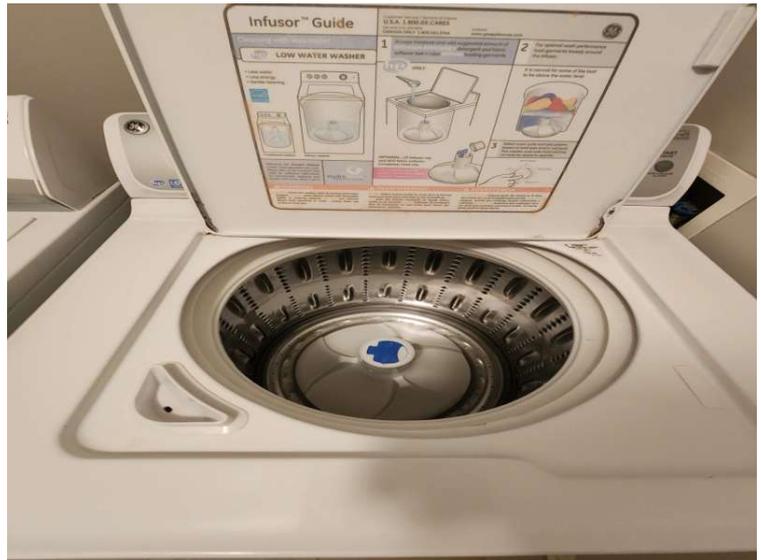
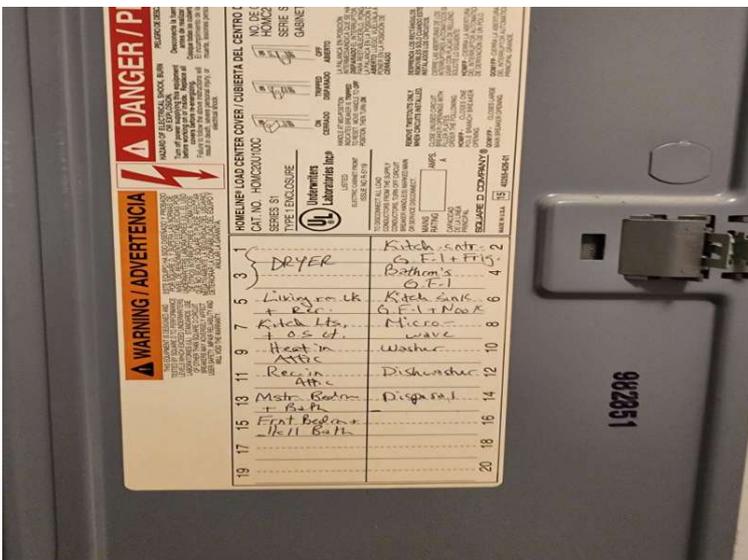
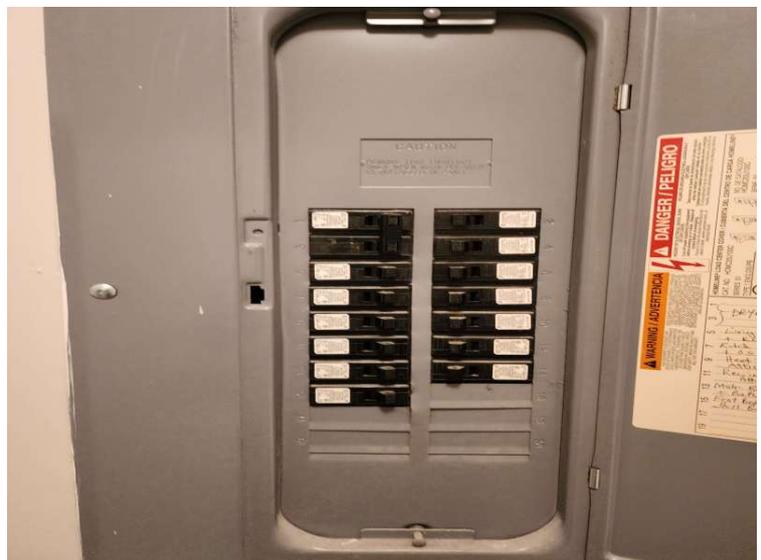
# Laundry/Utilities/Storage Area

| Item: | Results: |
|--|---|
| Floor, Walls and Ceiling condition? | Great |
| HVAC appears in good working condition? | Yes |
| Electrical panel is accessible and in good condition? | Yes |
| Electrical sources throughout the residence found to be/have? | In good condition |

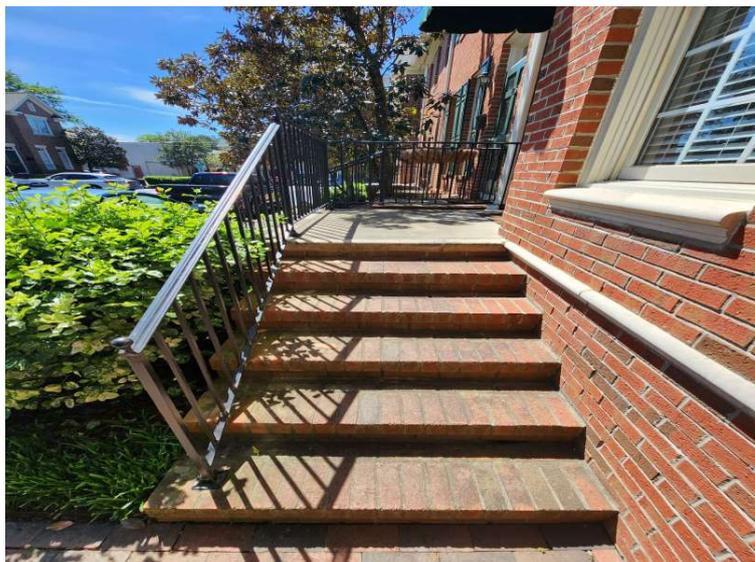
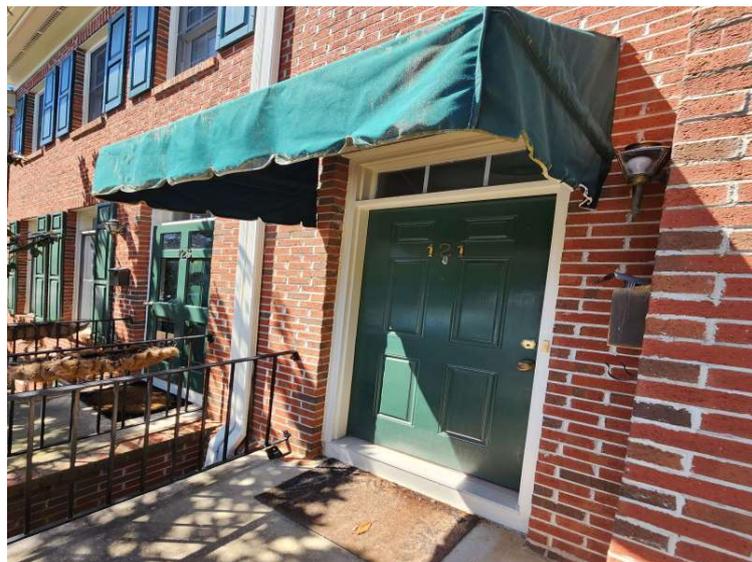
## Exterior of residence

| Item: | Results: |
|--|---|
| Exterior siding condition? | Great - No Issues |
| Condition of gutters oir downspouts | Great - No Issue |
| Exterior roof condition? | Good |
