# Periodic Smoke Alarm & Property Survey

2250 Old Brick Rd  
Glen Allen VA 23060

**Survey date:** 2025-02-25

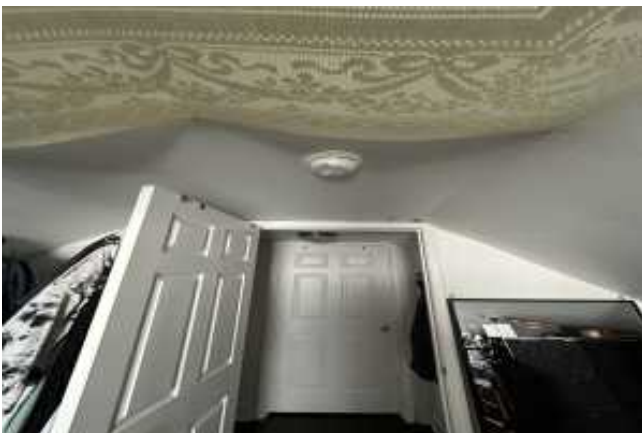
Bedroom smoke detector

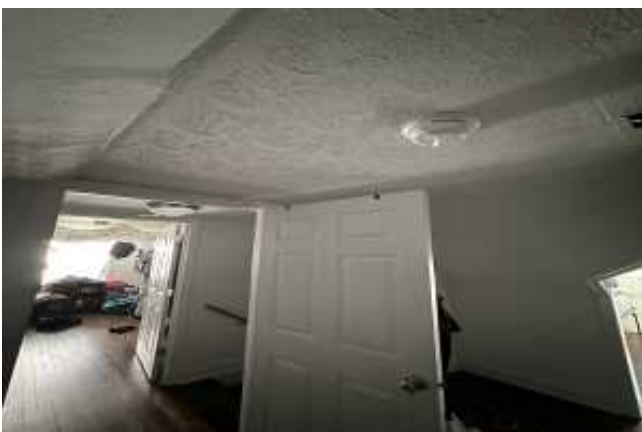
Bedroom smoke detector

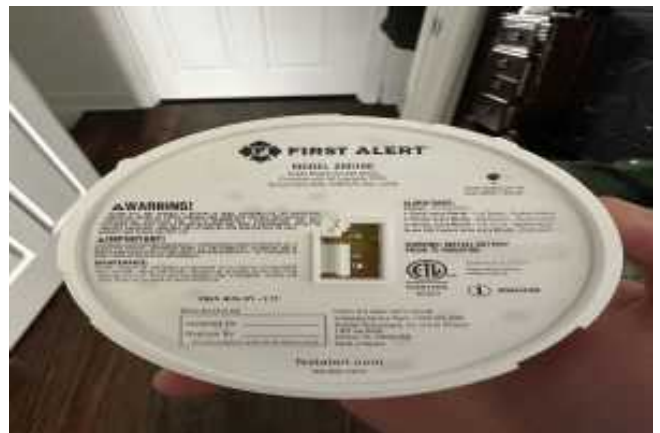
Bedroom smoke detector

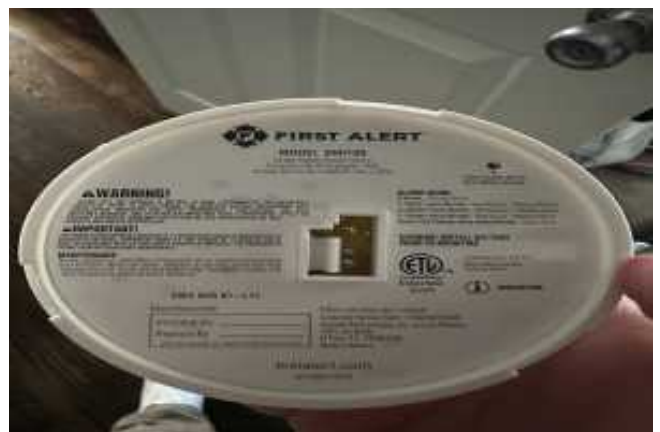
Bedroom smoke detector

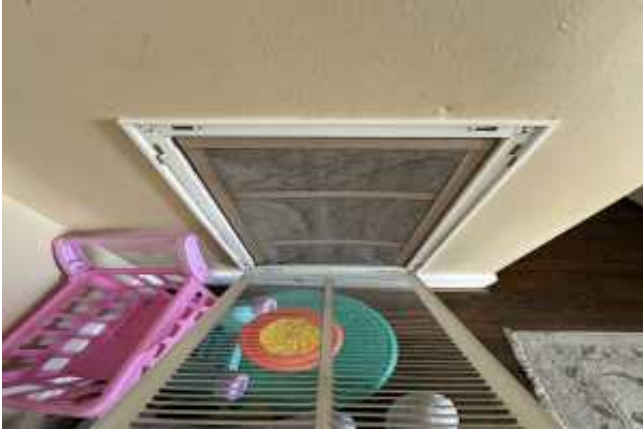
Dirty 14x20x1 in common area

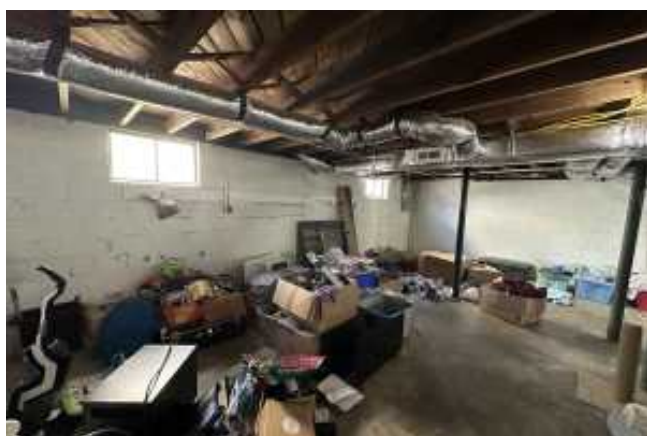
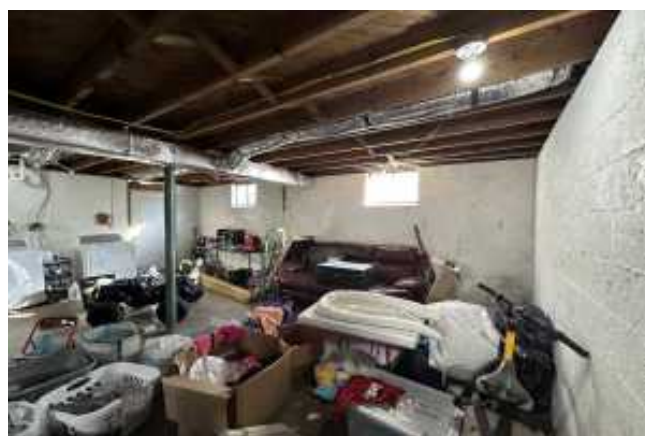
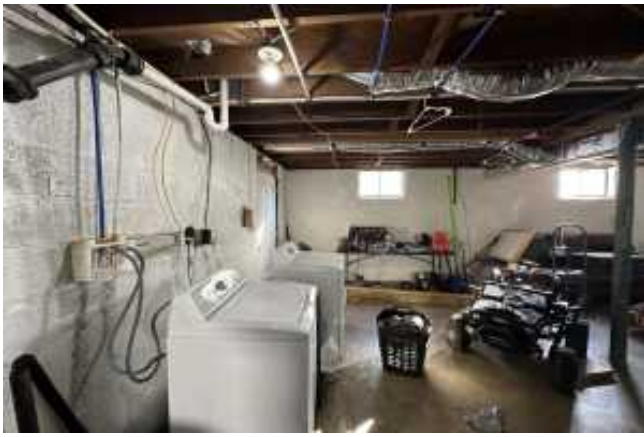
Item:	Results:
Does the residence have a basement?	Yes
Area is clean and not cluttered?	No
Fireplace is present?	No
A bedroom is present in basement/lowest level	No
A bathroom is present in basement/lowest level	No
Additional notes or findings:	Lots of clutter in this area, but was able to walkthrough and access necessary areas for inspection.

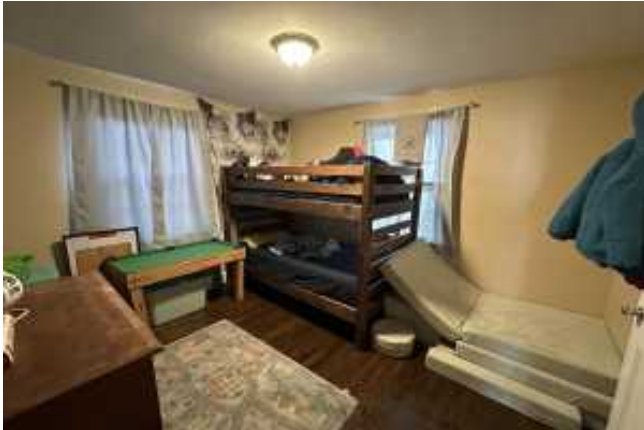
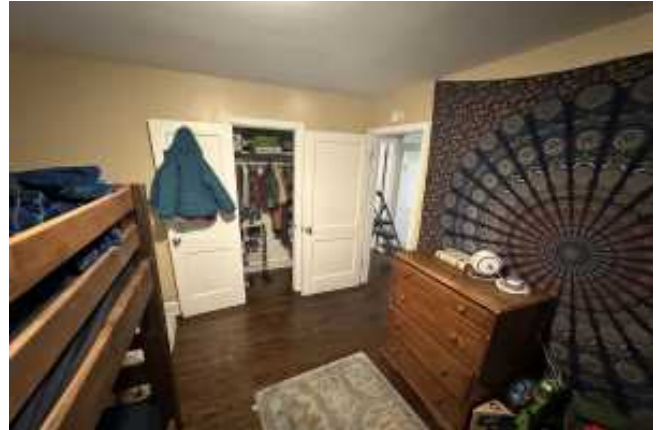
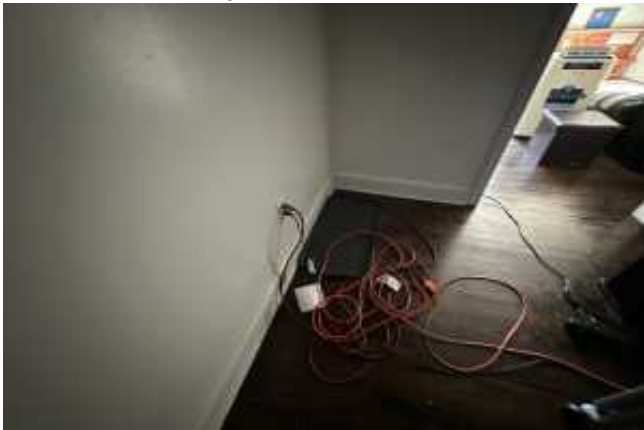
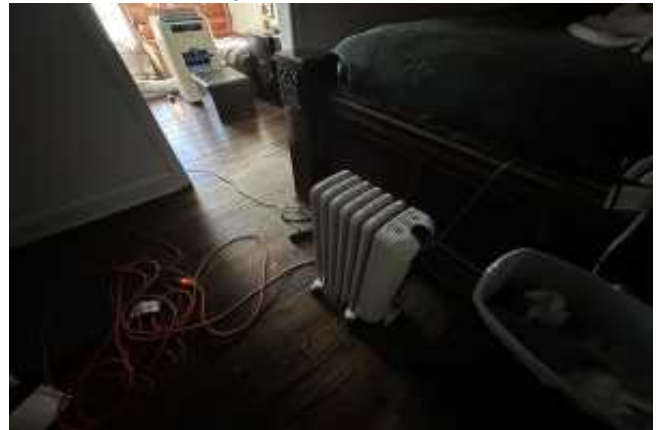
Item:	Results:
Total bedrooms	4
Bedroom has two operational and clear means of egress to separate locations inside or outside of the residence?	No - Lack of proper egress
Floor covering?	Wood, laminate or linoleum
Condition of floor covering?	Good - Moderate Wear
Walls and Ceiling condition?	Good - Moderate Wear
Additional notes or findings:	In the bedroom upstairs and to the left, the tenant has a bed blocking egress to one window, but has clear egress to another accessible window.

Item:	Results:
Any maintenance issues?	Yes
Recommended Maintenance	<p>Both bedrooms upstairs had some wall damage that should be addressed. In one bedroom directly above the doorframe, it appears that there was past damage, even possible burning?</p> <p>The other room has some cracking in the wall, potentially foundation settling.</p>

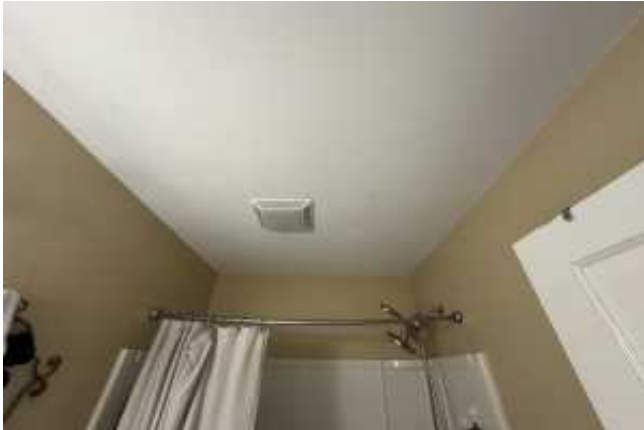
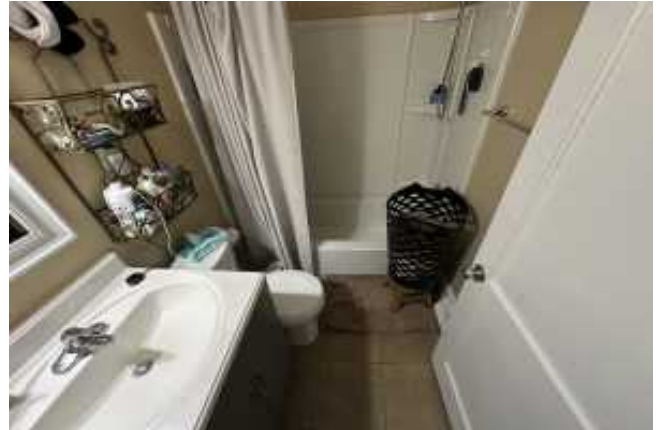
Item:	Results:
Total full bathrooms	1
Water Sources?	Stainless Braided Cables
Bathroom vent fan is?	Dirty
Shower or tub condition?	Good condition
Condition of floor covering?	Good - Moderate wear and tear
Condition of walls and ceiling?	Good
Vanity in good condition?	Yes
Light fixtures are in good working condition?	No
Condition of light fixtures	Light bulbs out or missing
Additional notes or findings:	--

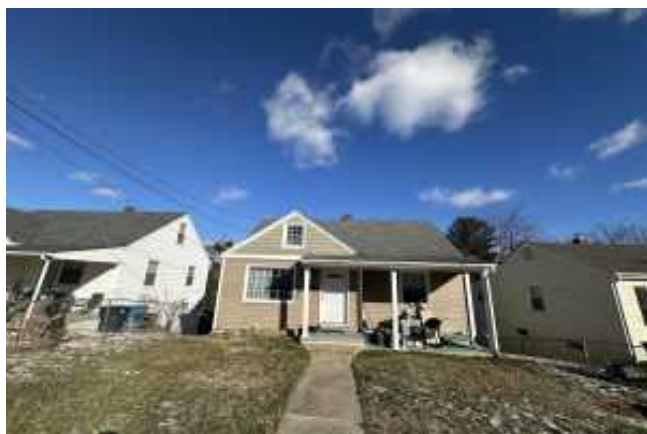
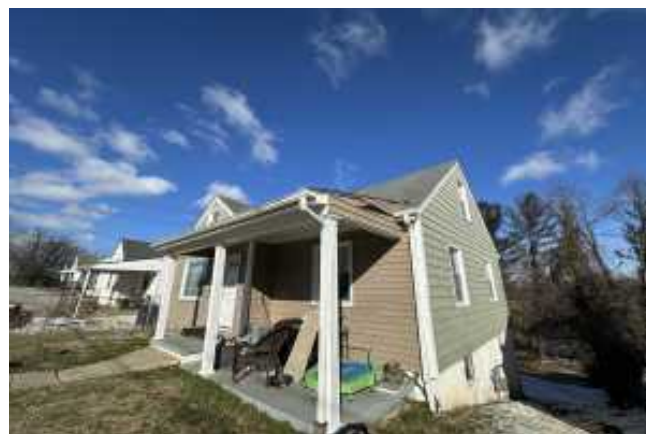
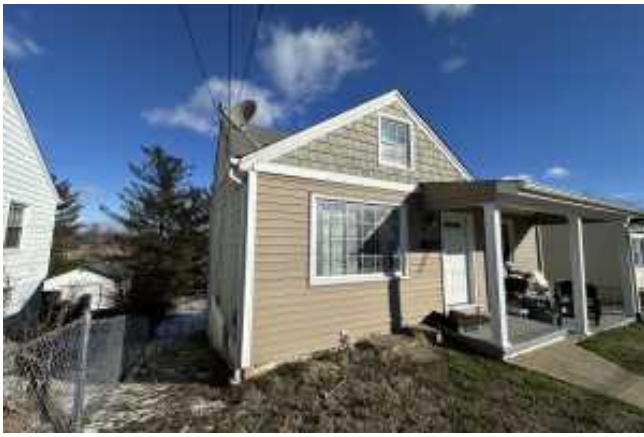
Item:	Results:
Overall Impression during exterior walk around of residence?	Good
Address clearly visible from street?	Yes
Exterior siding condition?	Good - Dirty
Does the residence have gutters and downspouts	Yes
Condition of gutters and downspouts	Good - Dirty
Property has a fence?	No
Has outdoor grill or fireplace?	None
Has pool or hot tub?	No
Has exterior patio deck or balcony?	No
Ground level appearance of exterior roof condition?	Good
Exterior landscaping?	Exterior flower beds/lawn/trees/shrubs are maintained in good condition and well kept
Driveway/walkway/sidewalk	Driveway/sidewalk/walkway are in good condition with no signs of cracking, organic growth or safety concerns
Residence is a multi-family unit?	No
Additional notes or findings:	Front porch appeared to be a little cluttered, but overall walkthrough was good.
